ENVIRONMENTAL TEST REPORT

CUSTOMER	Perfectron Co., Ltd. Taiwan Branch		JOB NO.	A-7935
ADDRESS	2F., No.190, Sec.2, Zhongxing Rd., Xindian Dist., New Taipei City 23146, Taiwan (R.O.C.)			
SPECIMEN	Rack-mount Fanless computer		REPORT NO.	C-8990
QUANTITY	1 set	MODEL	HORUS200 Serial model: HORUS200-XXXX (X=0~9, A~Z, a~z, - or blank, for different markets)

(According to MIL-STD-810F 5 May 2003)

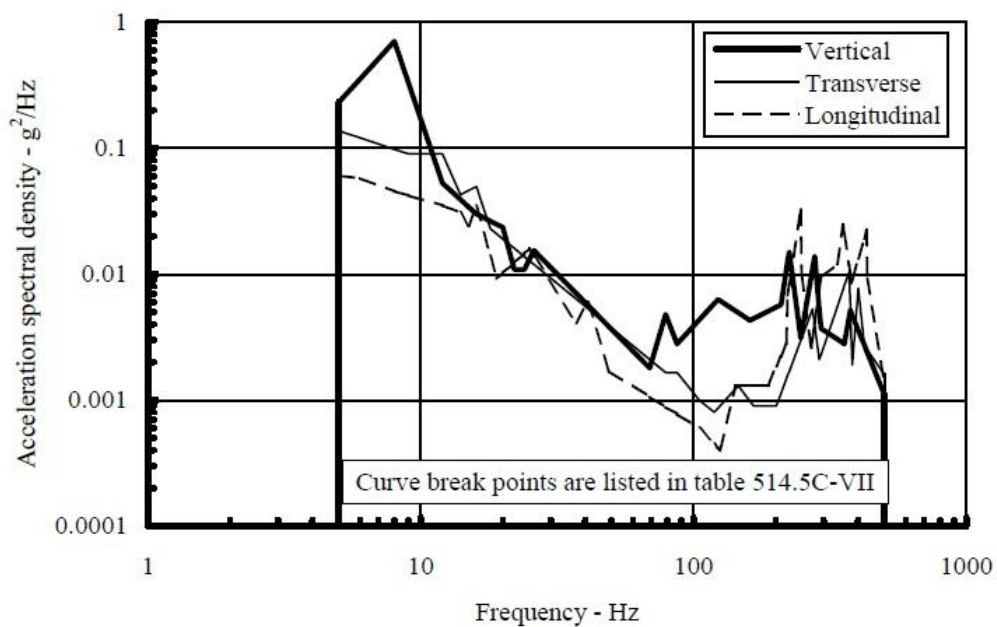
FIGURE 514.5C-3. Composite wheeled vehicle vibration exposure.

Composite wheeled vehical vibration exposures figure 514.5C-3					
Vertical		Transverse		Longitudinal	
Hz	g ² /Hz	Hz	g ² /Hz	Hz	g ² /Hz
5	0.2366	5	0.1344	5	0.0593
8	0.6889	7	0.1075	8	0.0499
12	0.0507	8	0.1279	15	0.0255
21	0.0202	14	0.0366	16	0.0344
23	0.0301	16	0.0485	20	0.0134
24	0.0109	17	0.0326	23	0.0608
26	0.0150	19	0.0836	25	0.0148
49	0.0038	23	0.0147	37	0.0040
51	0.0054	116	0.0008	41	0.0059
61	0.0023	145	0.0013	49	0.0016
69	0.0111	164	0.0009	63	0.0011
74	0.0029	201	0.0009	69	0.0040
78	0.0048	270	0.0051	78	0.0008
84	0.0033	298	0.0021	94	0.0020
90	0.0052	364	0.0099	98	0.0013
93	0.0034	375	0.0019	101	0.0025
123	0.0083	394	0.0073	104	0.0014
160	0.0041	418	0.0027	111	0.0024
207	0.0055	500	0.0016	114	0.0014
224	0.0139	1.62 g rms		117	0.0020
245	0.0031			121	0.0012
276	0.0129			139	0.0024
287	0.0036			155	0.0021
353	0.0027			161	0.0034
375	0.0049			205	0.0042
500	0.0010			247	0.0303

2.20 g rms				257	0.0027
		293	0.0092		
		330	0.0116		
		353	0.0231		
		379	0.0083		
		427	0.0220		
		500	0.0014		
				2.05 g rms

Test procedure: According to MIL-STD-810F Method 514.5 Table 514.5C-VII
and Figure 514.5C-3. (Table and figure were shown as next
two pages.)

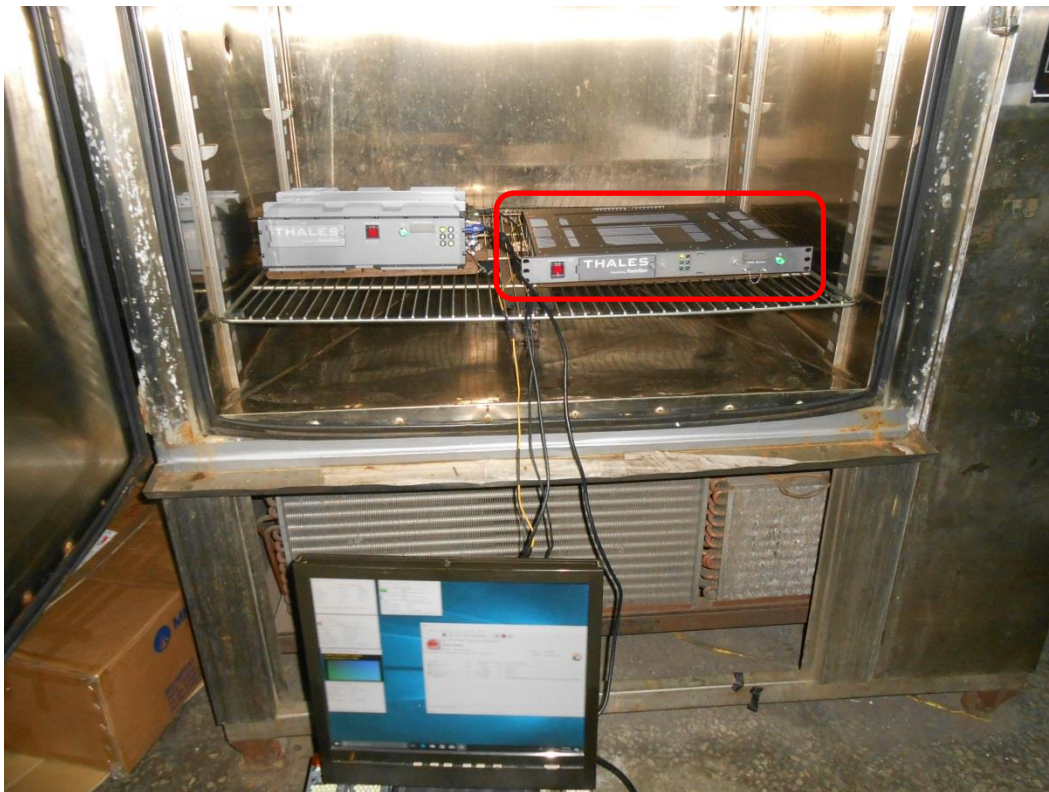
Fig.1 : Low / High temperature storage / Operating and
Humidity test

1. Test configuration was shown in Fig.1.
2. The testing data were shown in Fig.2.
3. Test specimen was visually inspected after test. No physical damage occurred.
4. The function of specimen was normal after the Low temperature storage test.

1. Test configuration was shown in Fig.1.
2. The testing data were shown in Fig.3.
3. Test specimen was visually inspected after test. No physical damage occurred.
4. The function of specimen was normal after the High temperature storage test.

1. Test configuration was shown in Fig.1.
2. The testing data were shown in Fig.4.
3. Test specimen was visually inspected after test. No physical damage occurred.
4. The function of specimen was normal during and after the Low temperature operating test.

1. Test configuration was shown in Fig.1.
2. The testing data were shown in Fig.5.
3. Test specimen was visually inspected after test. No physical damage occurred.
4. The function of specimen was normal during and after the High temperature operating test.

1. Test configuration was shown in Fig.1.
2. The testing data were shown in Fig.6A~Fig.6D.
3. Test specimen was visually inspected after test. There are some oxidation corrosion of screws, shown as Fig.6E.
4. The function of specimen was normal during and after the Humidity test.

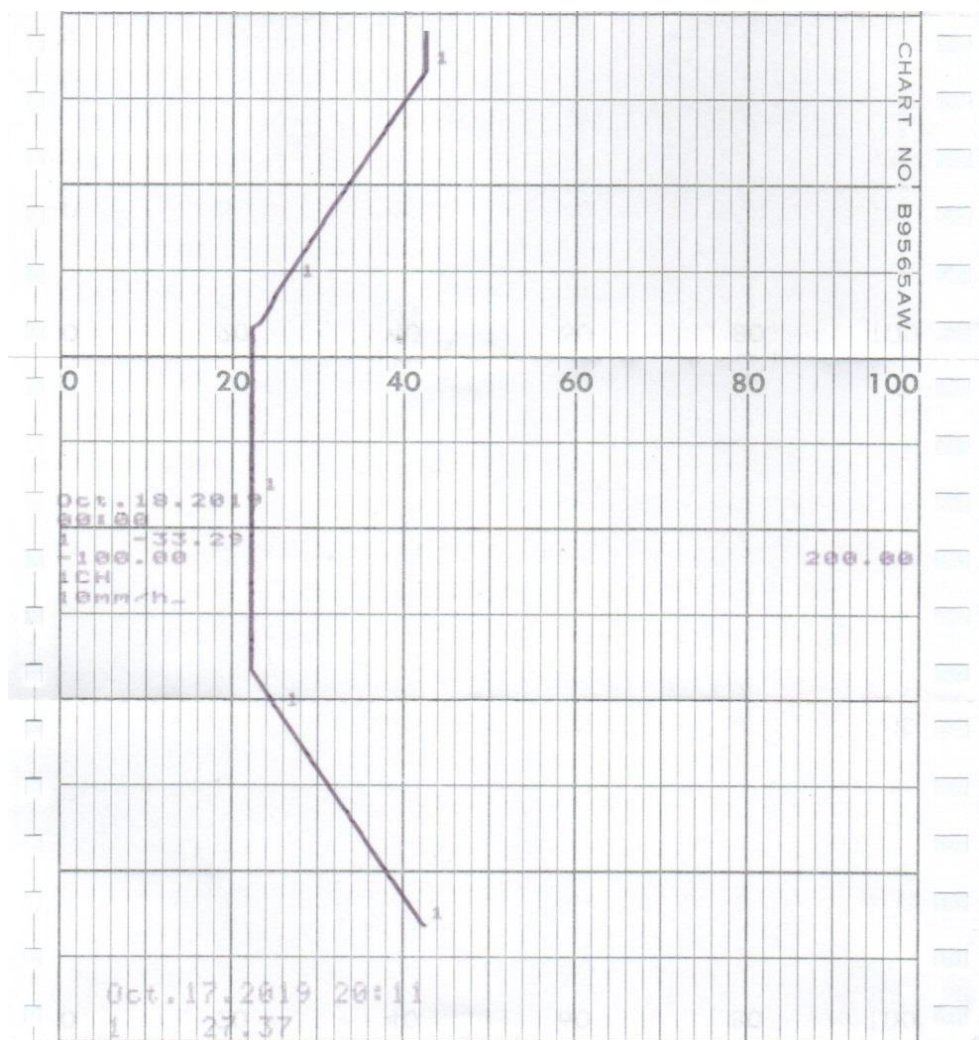
Fig. 2 : Low temperature storage test record

Temperature : -33°C , 4 hours, Change rate: $\leq 20^{\circ}\text{C}/\text{hour}$.

Temperature span: $-100.0^{\circ}\text{C} \sim +200.0^{\circ}\text{C}$, Temperature scale: $6^{\circ}\text{C}/\text{div}$.

Chart speed: 10 mm/hr

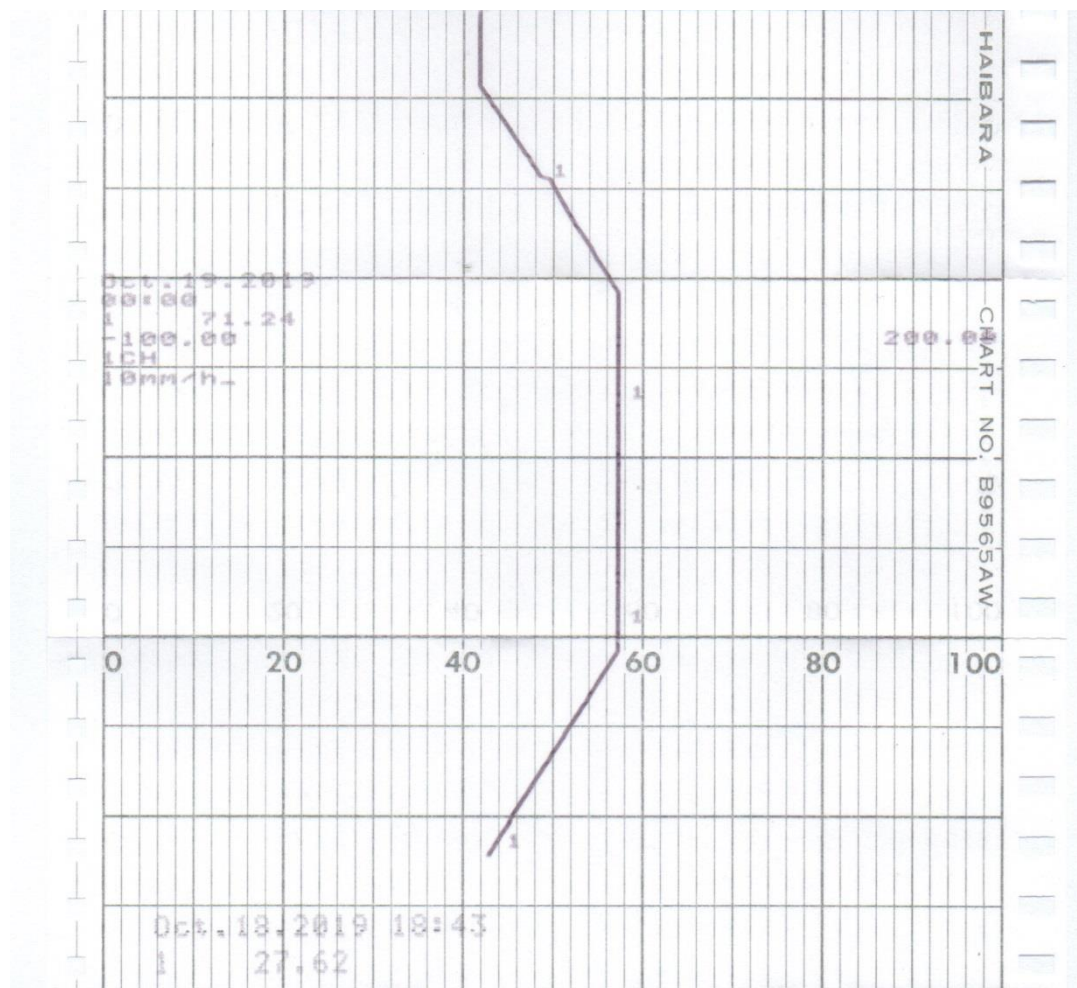
Fig. 3 : High temperature storage test record

Temperature : 71°C , 4 hours, Change rate: $\leq 20^{\circ}\text{C}/\text{hour}$.

Temperature span: $-100.0^{\circ}\text{C} \sim +200.0^{\circ}\text{C}$, Temperature scale: $6^{\circ}\text{C}/\text{div}$.
Chart speed: 10 mm/hr

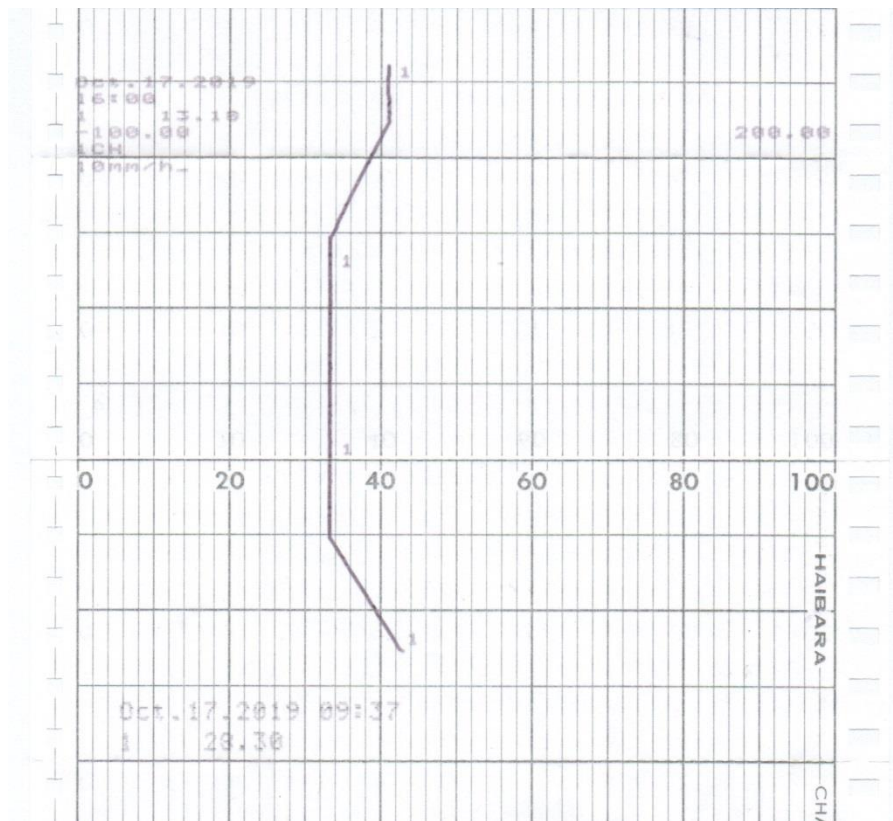
Fig. 4 : Low temperature operating test record

Temperature : 0°C , 4 hours, Change rate: $\leq 20^{\circ}\text{C}/\text{hour}$.

Temperature span: $-100.0^{\circ}\text{C} \sim +200.0^{\circ}\text{C}$, Temperature scale: $6^{\circ}\text{C}/\text{div.}$

Chart speed: 10 mm/hr

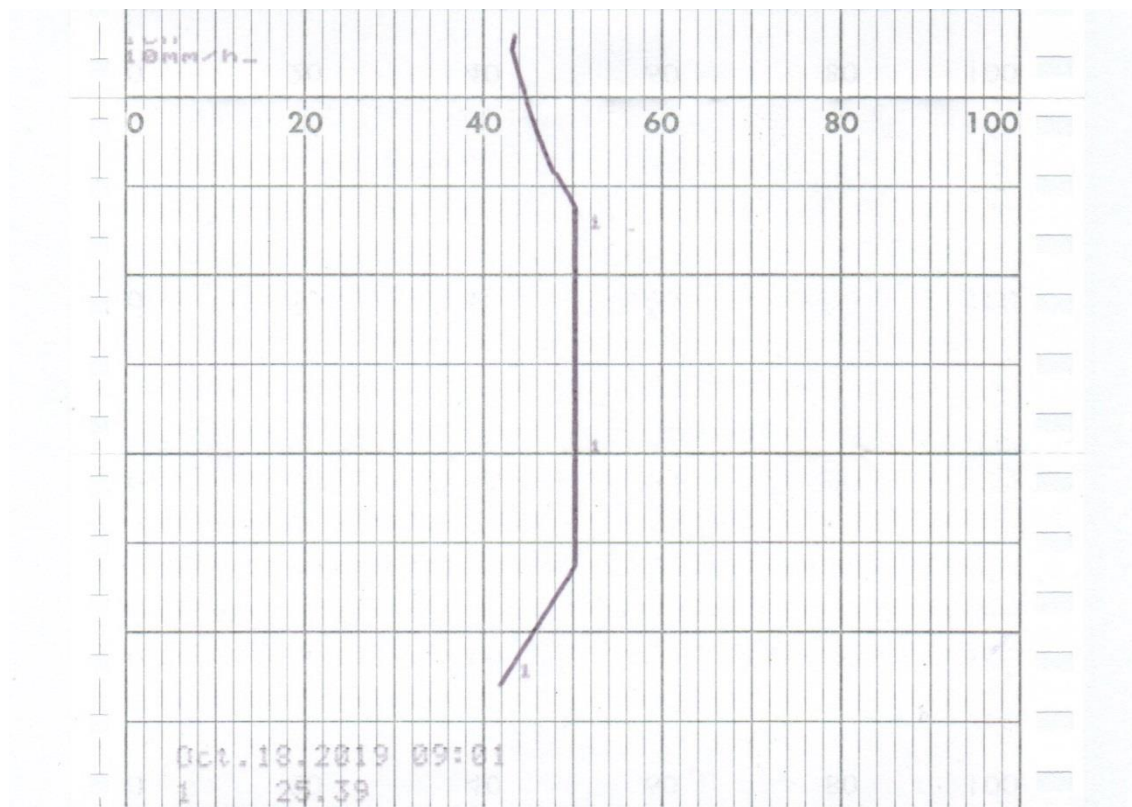
Fig. 5 : High temperature operating test record

Temperature : 50°C , 4 hours, Change rate: $\leq 20^{\circ}\text{C}/\text{hour}$.

Temperature span: $-100.0^{\circ}\text{C} \sim +200.0^{\circ}\text{C}$, Temperature scale: $6^{\circ}\text{C}/\text{div}$.

Chart speed: 10 mm/hr

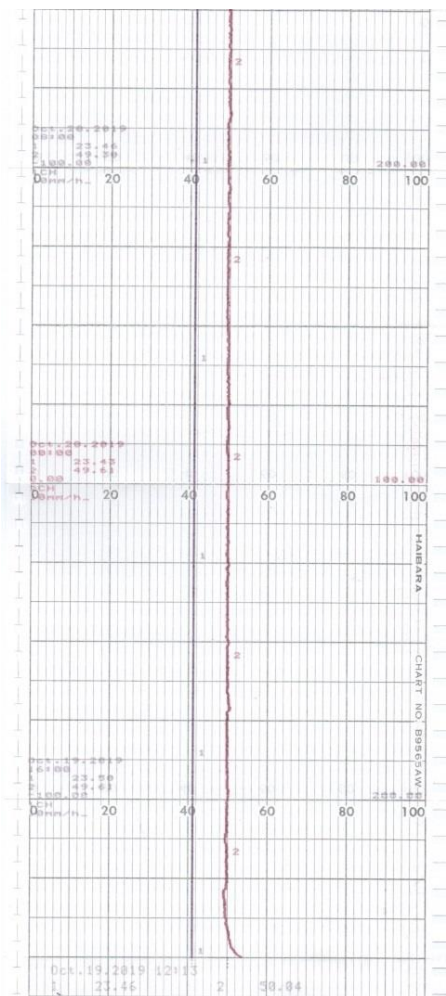
Fig.6A : Humidity test record (Pre-conditioning period)

Pre-conditioning period: $23 \pm 2^{\circ}\text{C}$ and $50 \pm 5\% \text{RH}$, maintain for 24 hours.
 $30^{\circ}\text{C} \sim 60^{\circ}\text{C}$, $85\% \sim 95\% \text{RH}$ without condensation, 24 hours/cycle, conduct 10 cycles.

Temperature span: $-100.0^{\circ}\text{C} \sim +200.0^{\circ}\text{C}$, Temperature scale: $6^{\circ}\text{C}/\text{div.}$
Humidity span: $0\% \sim 100\%(\text{RH})$, Humidity scale: $2\%(\text{RH})/\text{div.}$
Chart speed: 10 mm/hr.

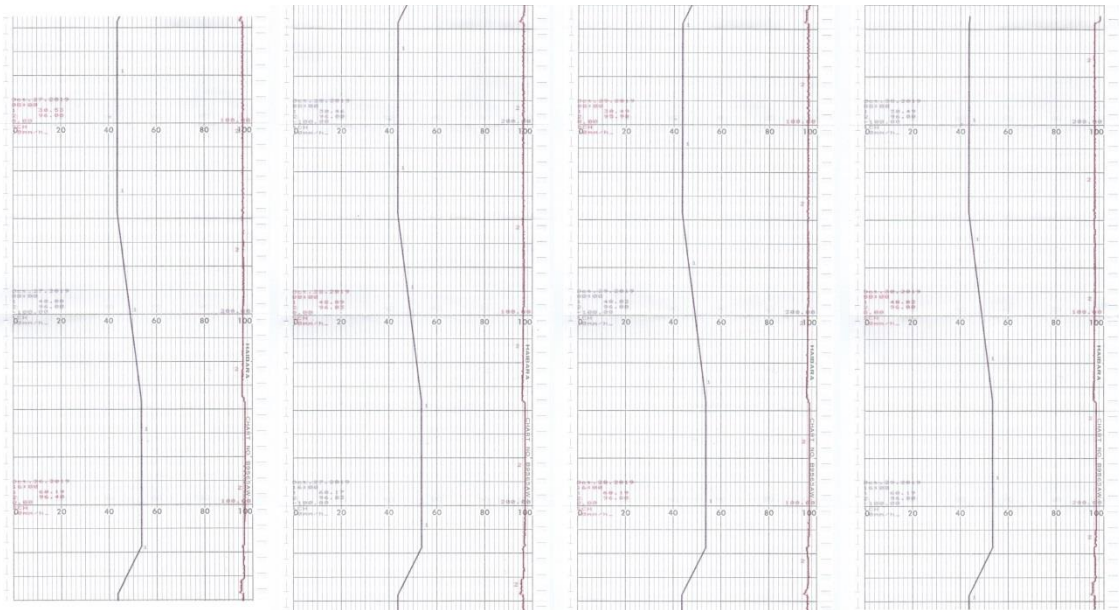
Fig. 6D : Humidity test record (cycle 7- 10)

Temperature span: $-100.0^{\circ}\text{C} \sim +200.0^{\circ}\text{C}$, Temperature scale: $6^{\circ}\text{C}/\text{div.}$
Humidity span: $0\% \sim 100\%(\text{RH})$, Humidity scale: $2\%(\text{RH})/\text{div.}$
Chart speed: 10 mm/hr.

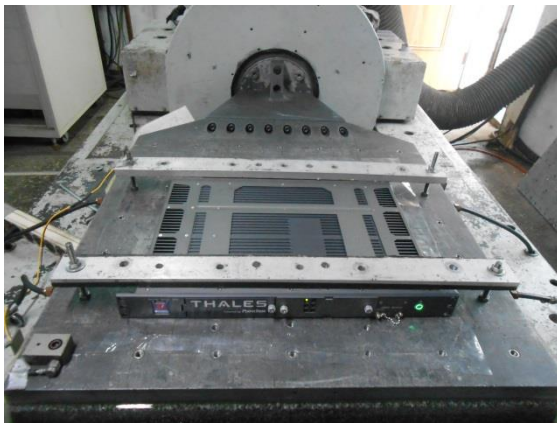
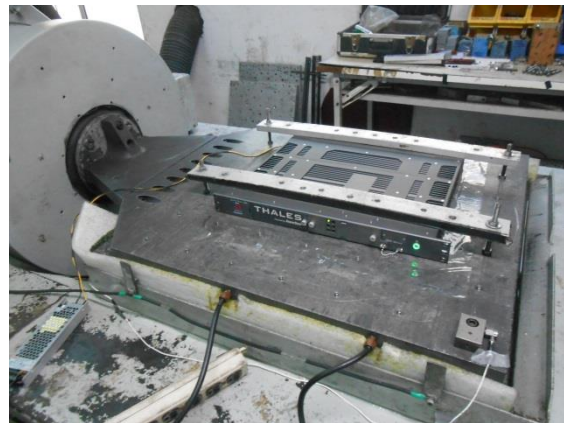
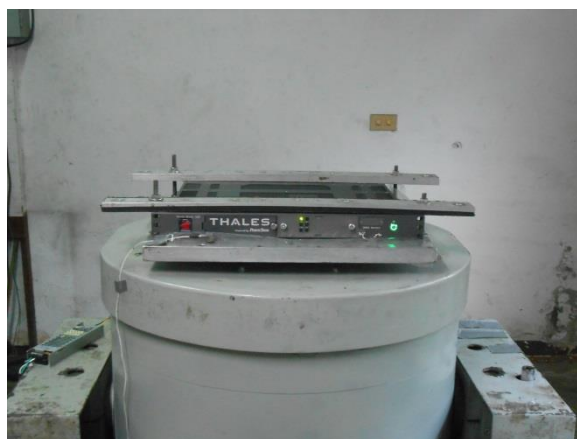
Fig. 7 : Random Vibration Test

1. Test configuration was shown in Fig.7.
2. The testing data were shown in Fig.8.
3. Test specimen was visually inspected after test. No physical damage occurred.
4. The function of specimen was normal during and after the Composite wheeled vehicle vibration test.

1. Test configurations were shown in Fig.7.
2. The testing data were shown in Fig.9.
3. Test specimen was visually inspected after test. No physical damage occurred.
4. The function of specimen was normal during and after Shock test.

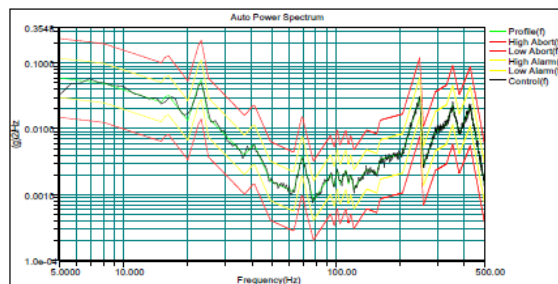
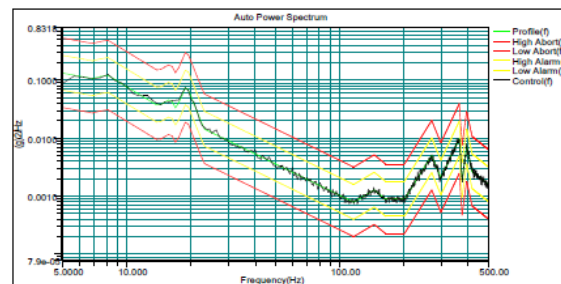
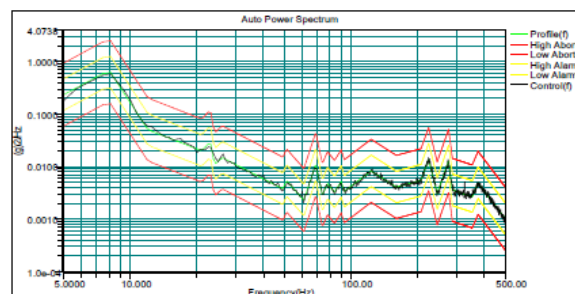
Fig. 8: Random Vibration Test Data

G_{rms} level: Vertical 2.20 g_{rms}, Transverse 1.62 g_{rms}, Longitudinal 2.05 g_{rms}.

Current Level: 100 % Demand RMS: 2.0973 g Control RMS: 2.10529 g
Frame Time: 1.600000 (s) Lines: 800 dF: 0.625000 Hz
DOF: 150 Test Elapsed: 00:40:19 Remaining Time: 00:00:00
Data was saved as a file at time: 2019-10-9 PM 03:55:58

Current Level: 100 % Demand RMS: 1.59513 g Control RMS: 1.60235 g
Frame Time: 1.600000 (s) Lines: 800 dF: 0.625000 Hz
DOF: 150 Test Elapsed: 00:40:19 Remaining Time: 00:00:00
Data was saved as a file at time: 2019-10-9 PM 04:49:37

Current Level: 100 % Demand RMS: 2.18002 g Control RMS: 2.1824 g
Frame Time: 1.600000 (s) Lines: 800 dF: 0.625000 Hz
DOF: 150 Test Elapsed: 00:40:19 Remaining Time: 00:00:00
Data was saved as a file at time: 2019-10-9 PM 02:52:22

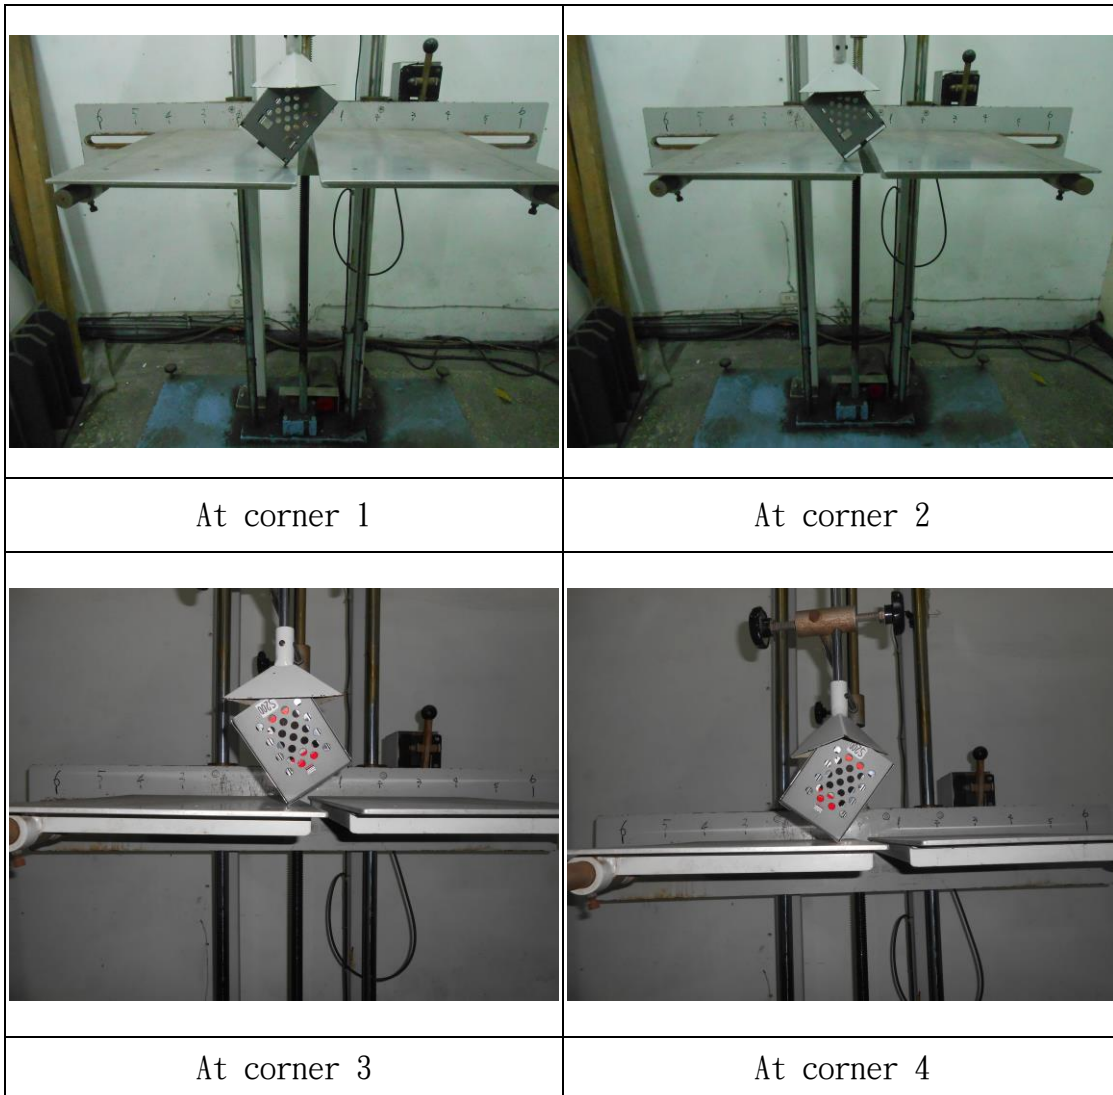
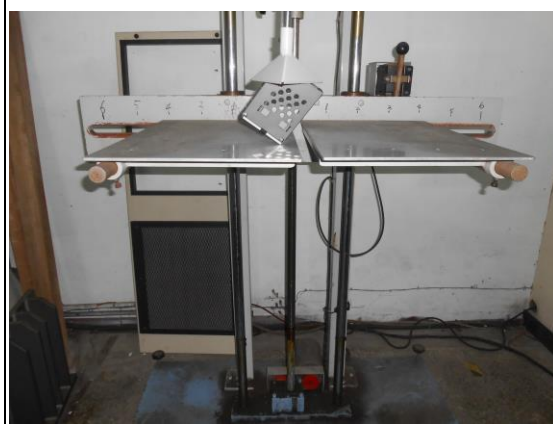
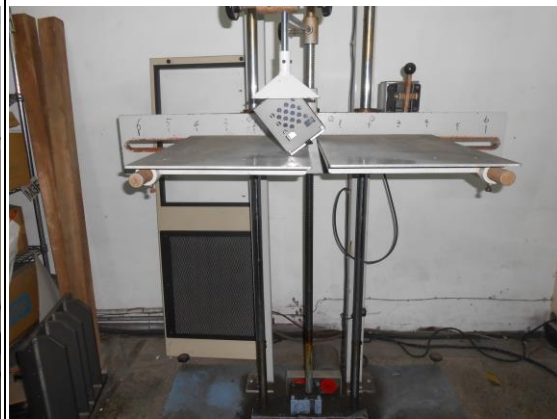
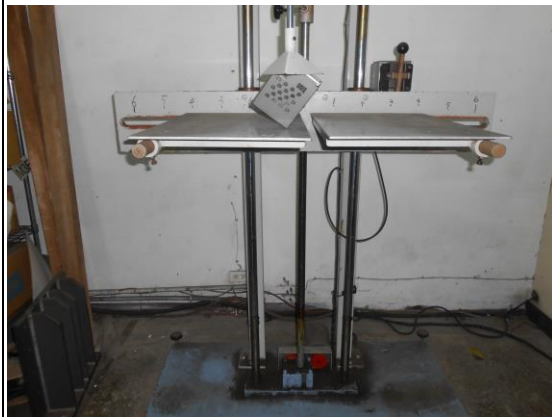
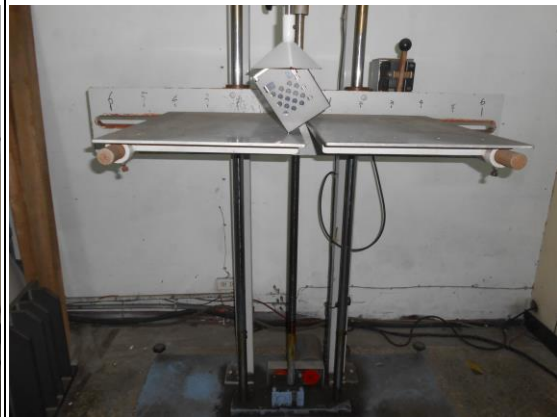
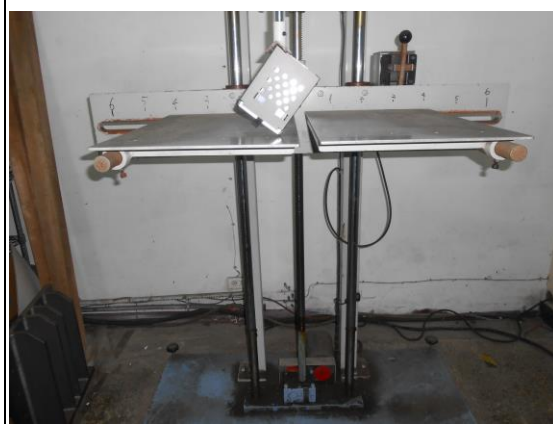
Height : 122 cm.

Times of drop : 1 time for each of

1. Test configurations were shown in Fig.10A~ Fig.10H.
2. Test specimen was visually inspected after test. There are some distortions on metal casing. The Dual Removable Solid-State Disk can be installed into Rack-mount Fanless Computer, and work normal.
3. The function of specimen was normal after Drop test.
