REPORT NO : VT-160816-2

SPECIMEN : SR10-XXX

TEST / INSPECTION ITEMS : Vibration Test

## TESTING / INSPECTION REPORT

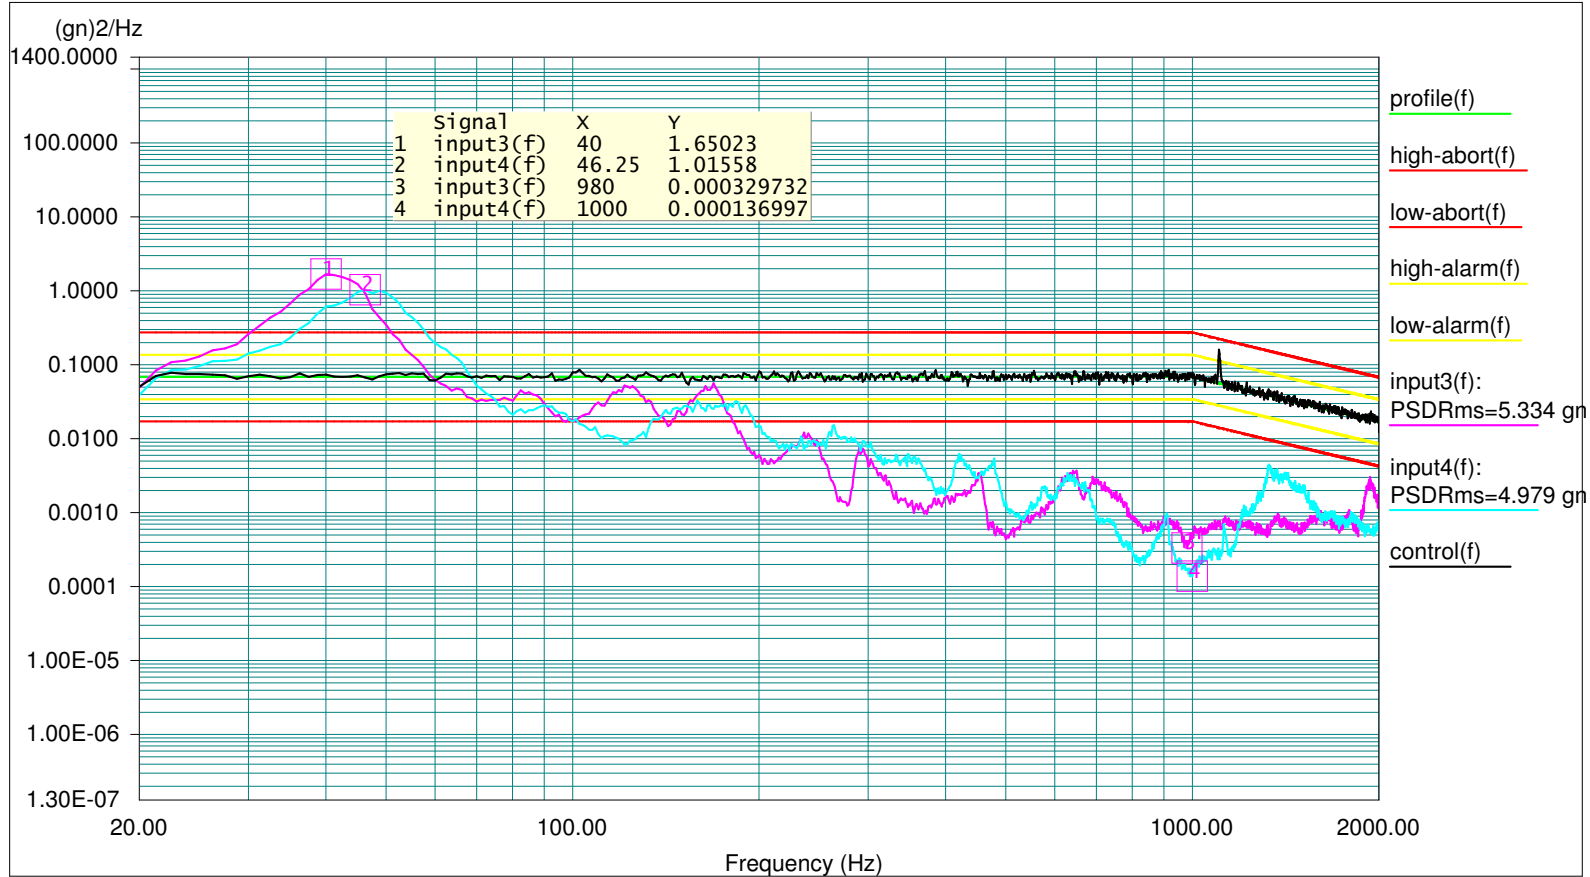
Z axis

Control RMS: 10.395703 gn Full Level Elapsed Time: 01:00:00 Lines: 1600 Frame Time: 0.800000 Seconds

Demand RMS: 10.001100 gn Remaining Time: 00:00:00 DOF: 154 dF: 1.250000 Hz
