ENVIRONMENTAL TEST REPORT

CUSTOMER	Perfectron Co., Ltd. Taiwan Branch		JOB NO.	A-7935
ADDRESS	2F., No.190, Sec.2, Zhongxing Rd., Xindian Dist., New Taipei City 23146, Taiwan (R.O.C.)			
SPECIMEN	Rugged Fanless computer		REPORT NO.	C-8989
QUANTITY	1 set	MODEL	SR800 Serial model: SR800-XXXX (X=0~9, A~Z, a~z, - or blank, for different markets)

(According to MIL-STD-810F 5 May 2003)

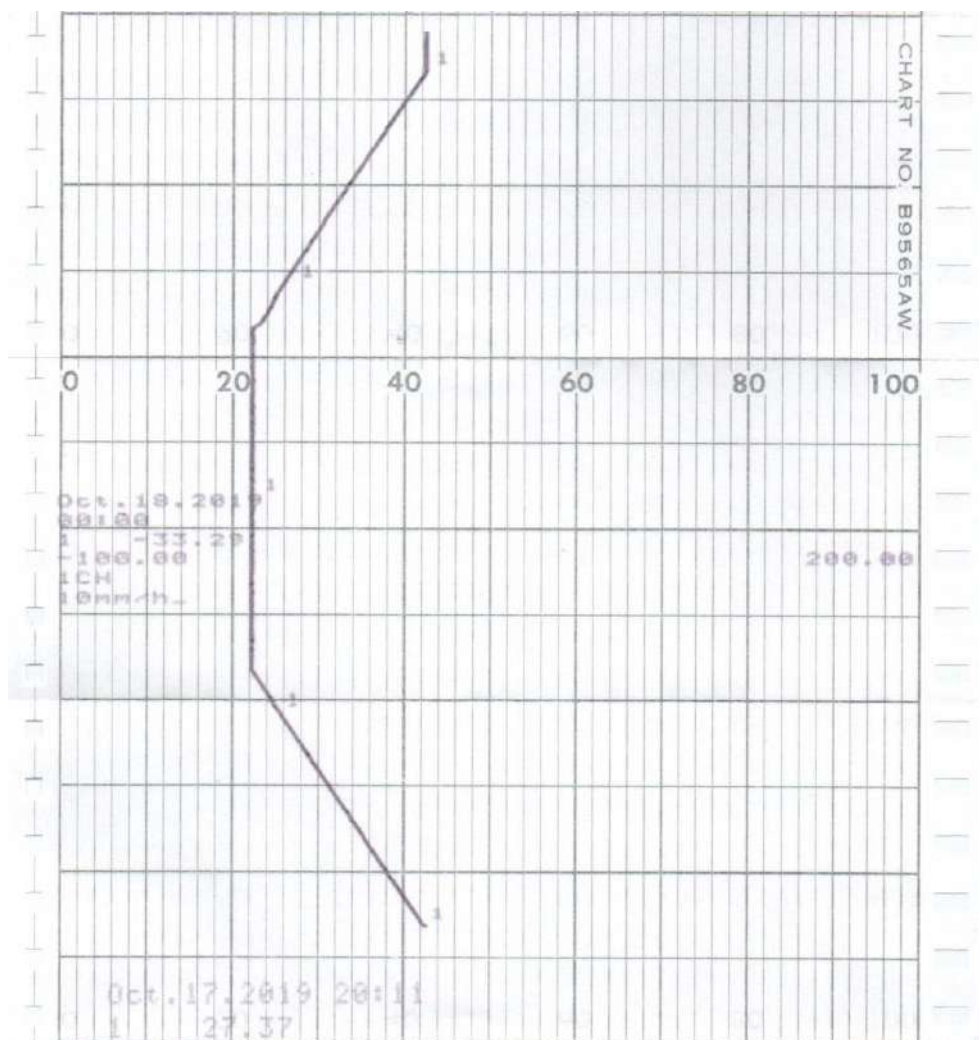
Fig. 2 : Low temperature storage test record

Temperature span : $-100.0^{\circ}\text{C} \sim +200.0^{\circ}\text{C}$, Temperature scale: $6^{\circ}\text{C}/\text{div}$.
Chart speed : 10 mm/hr

Temperature : -33°C , 4 hours, Change rate: $\leq 20^{\circ}\text{C}/\text{hour}$.

1. Test configuration was shown in Fig.1.
2. The testing data were shown in Fig.2.
3. Test specimen was visually inspected after test. No physical damage occurred.
4. The function of specimen was normal after the Low temperature storage test.

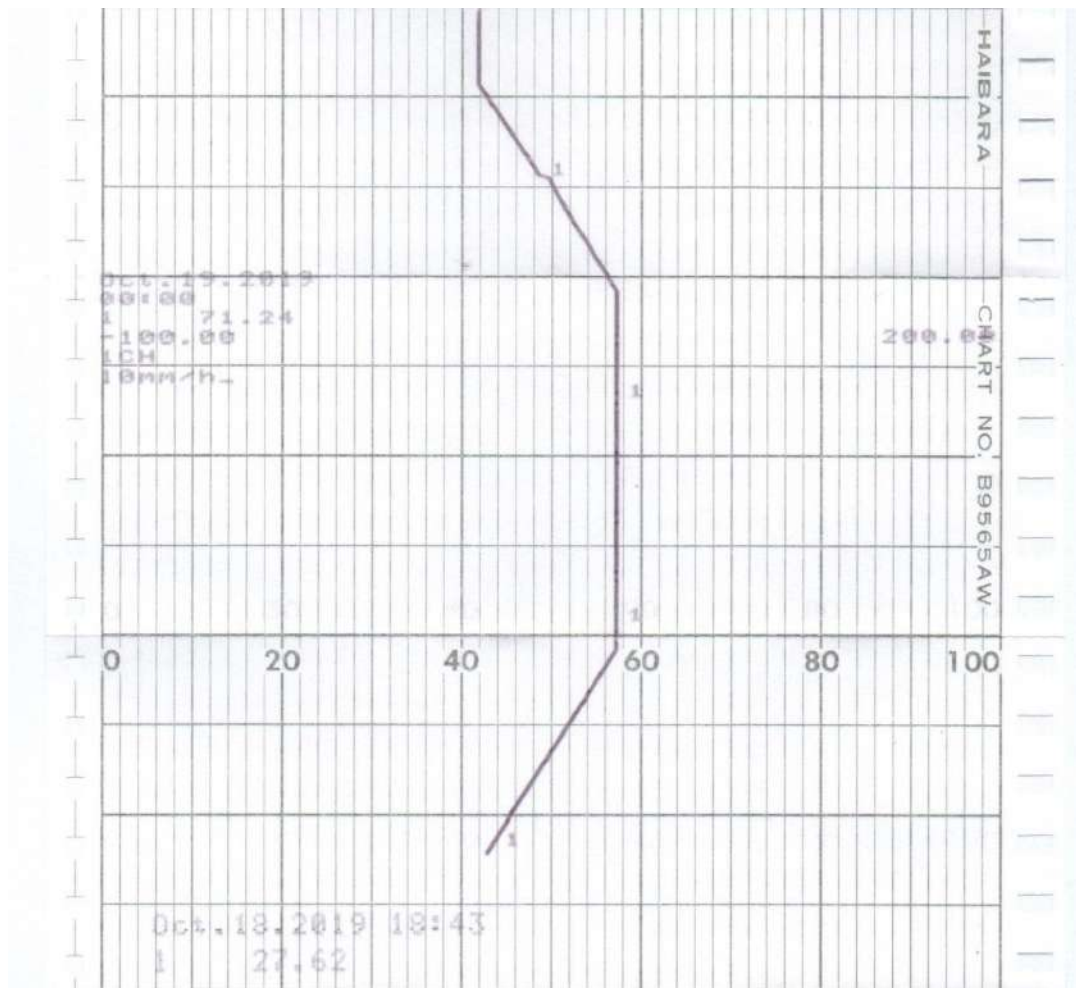
Fig. 3 : High temperature storage test record

Temperature span : $-100.0^{\circ}\text{C} \sim +200.0^{\circ}\text{C}$, Temperature scale: $6^{\circ}\text{C}/\text{div}$.
Chart speed : 10 mm/hr

Temperature : 71°C , 4 hours, Change rate: $\leq 20^{\circ}\text{C}/\text{hour}$.

1. Test configuration was shown in Fig.1.
2. The testing data were shown in Fig.3.
3. Test specimen was visually inspected after test. No physical damage occurred.
4. The function of specimen was normal after the High temperature storage test.

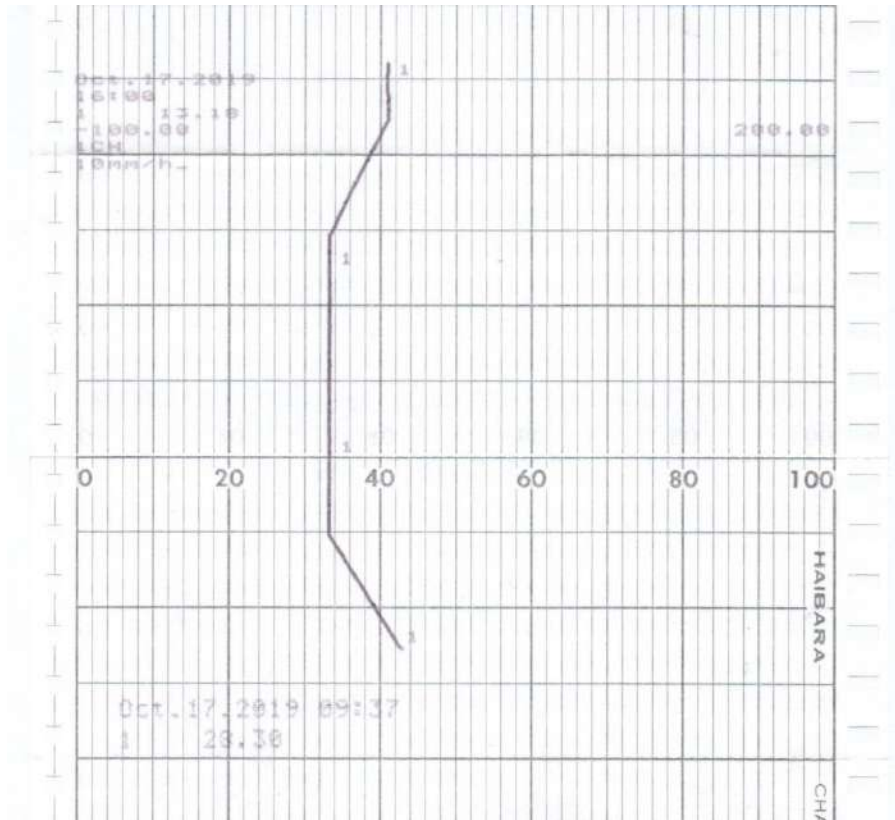
Fig. 4 : Low temperature operating test record

Temperature span : $-100.0^{\circ}\text{C} \sim +200.0^{\circ}\text{C}$, Temperature scale: $6^{\circ}\text{C}/\text{div}$.
Chart speed : 10 mm/hr

Temperature : 0°C , 4 hours, Change rate: $\leq 20^{\circ}\text{C}/\text{hour}$.

1. Test configuration was shown in Fig.1.
2. The testing data were shown in Fig.4.
3. Test specimen was visually inspected after test. No physical damage occurred.
4. The function of specimen was normal during and after the Low temperature operating test.

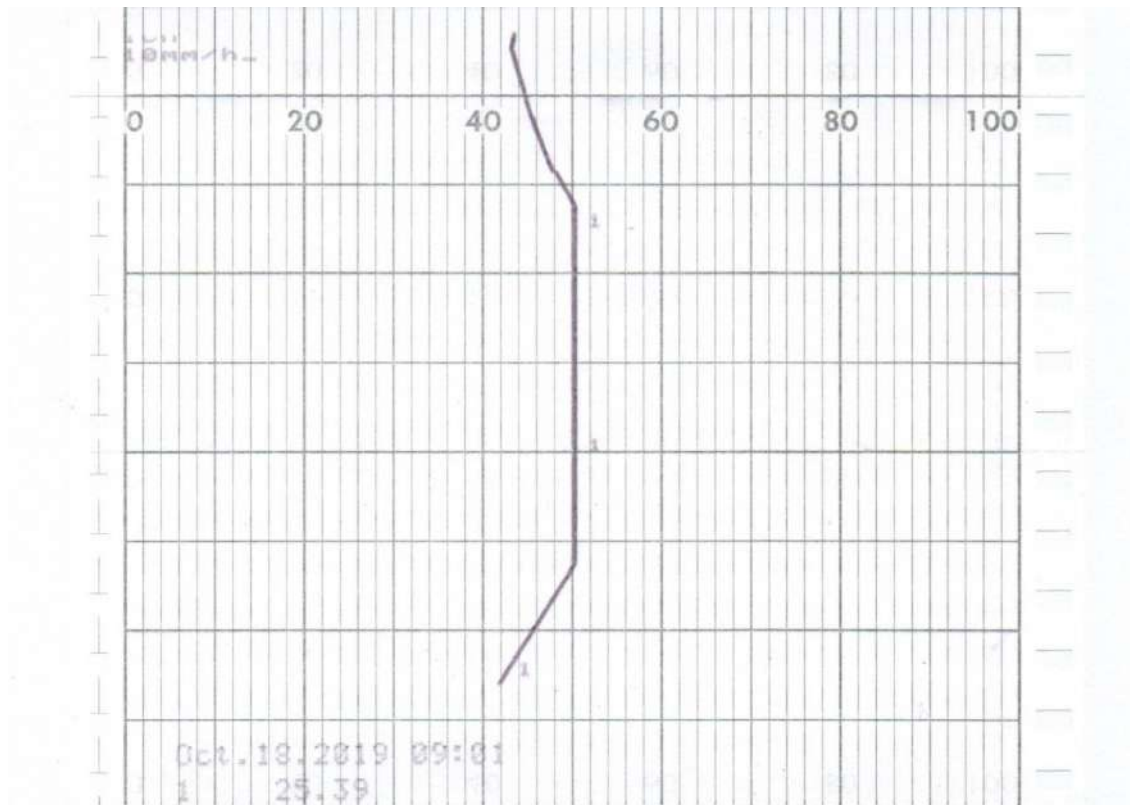
Fig. 5 : High temperature operating test record

Temperature span : $-100.0^{\circ}\text{C} \sim +200.0^{\circ}\text{C}$, Temperature scale: $6^{\circ}\text{C}/\text{div}$.
Chart speed : 10 mm/hr

Temperature : 50°C , 4 hours, Change rate: $\leq 20^{\circ}\text{C}/\text{hour}$.

1. Test configuration was shown in Fig.1.
2. The testing data were shown in Fig.5.
3. Test specimen was visually inspected after test. No physical damage occurred.
4. The function of specimen was normal during and after the High temperature operating test.

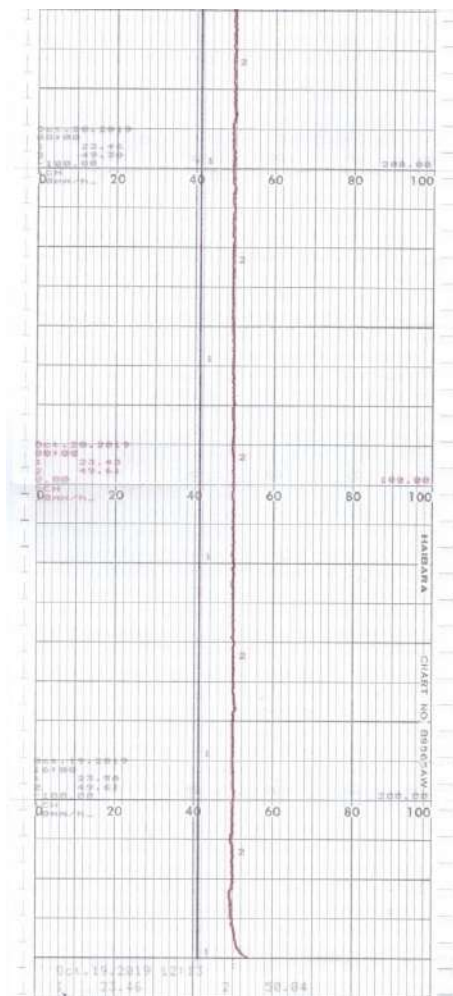
Fig. 6A : Humidity test record (Pre-conditioning period)

Temperature span : $-100.0^{\circ}\text{C} \sim +200.0^{\circ}\text{C}$, Temperature scale: $6^{\circ}\text{C}/\text{div}$.
Humidity span : $0\% \sim 100\%(\text{RH})$, Humidity scale : $2\%(\text{RH})/\text{div}$.
Chart speed : $10 \text{ mm}/\text{hr}$.

Pre-conditioning period: $23 \pm 2^{\circ}\text{C}$ and $50 \pm 5\% \text{RH}$, maintain for 24 hours.
 $30^{\circ}\text{C} \sim 60^{\circ}\text{C}$, $85\% \sim 95\% \text{RH}$ without condensation, 24 hours/cycle, conduct
10 cycles.

1. Test configuration was shown in Fig.1.
2. The testing data were shown in Fig. 6A~Fig.6D.
3. Test specimen was visually inspected after test. There are some oxidation corrosion of screws, shown as Fig. 6E.
4. The function of specimen was normal during and after the Humidity test.

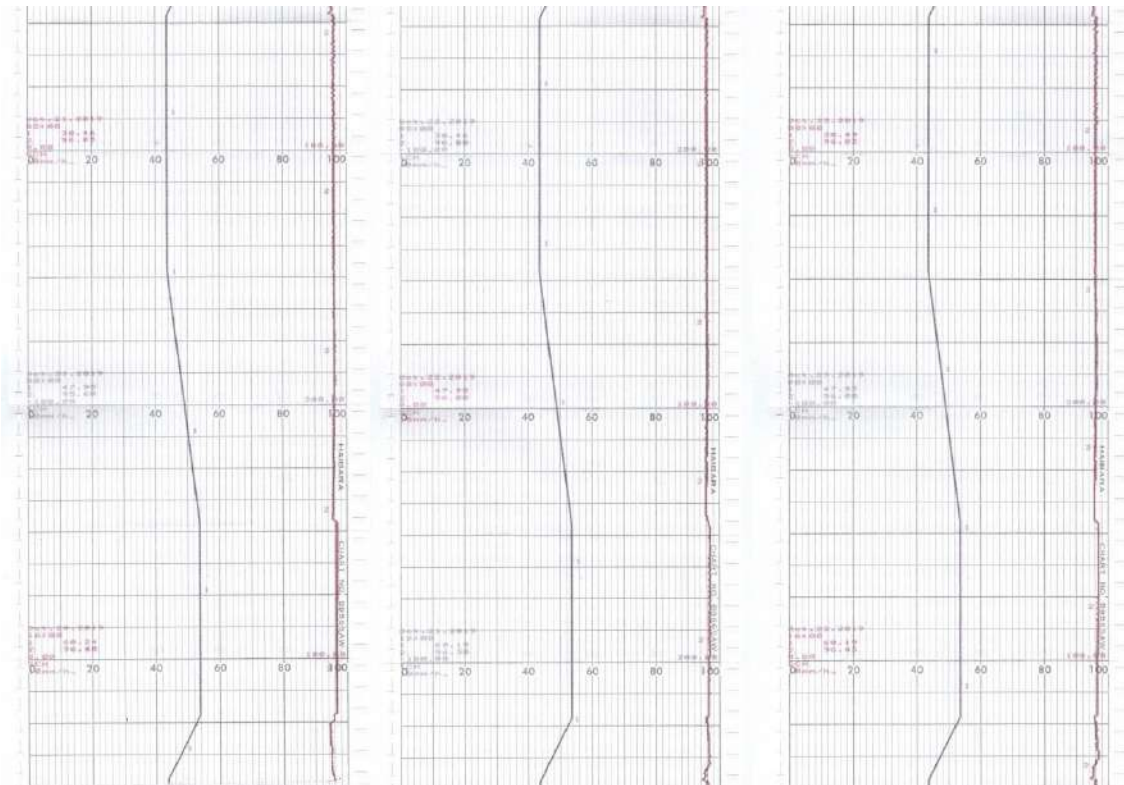
Fig.6B : Humidity test record (cycle 1- 3)

Temperature span : $-100.0^{\circ}\text{C} \sim +200.0^{\circ}\text{C}$, Temperature scale: $6^{\circ}\text{C}/\text{div}$.
Humidity span : $0\% \sim 100\%(\text{RH})$, Humidity scale : $2\%(\text{RH})/\text{div}$.
Chart speed : $10 \text{ mm}/\text{hr}$.

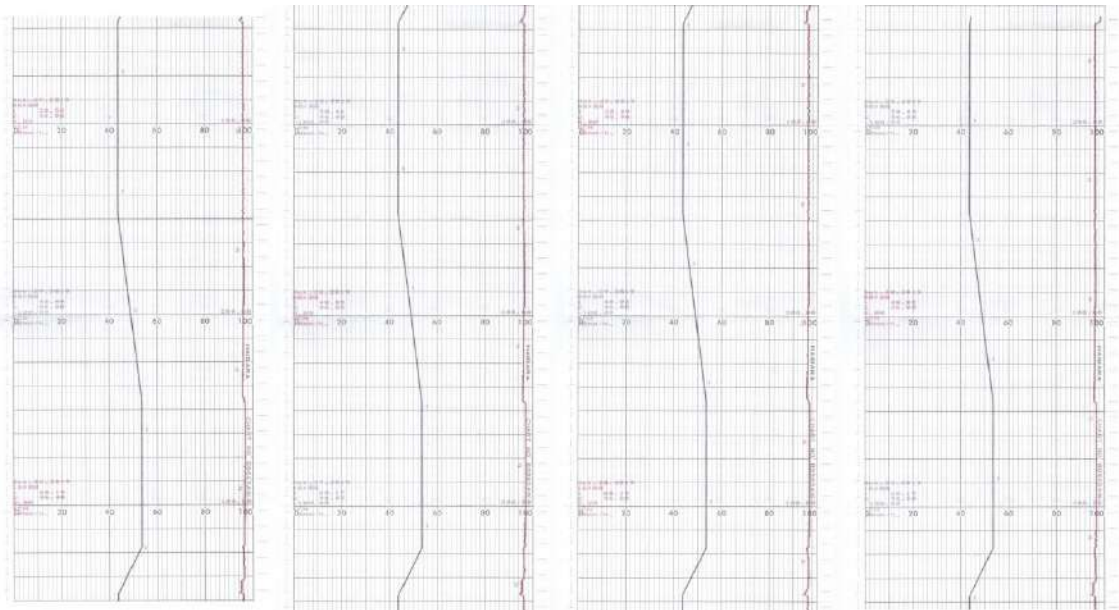
Fig. 6D : Humidity test record (cycle 7- 10)

Temperature span : $-100.0^{\circ}\text{C} \sim +200.0^{\circ}\text{C}$, Temperature scale: $6^{\circ}\text{C}/\text{div}$.
Humidity span : $0\% \sim 100\%(\text{RH})$, Humidity scale : $2\%(\text{RH})/\text{div}$.
Chart speed : $10 \text{ mm}/\text{hr}$.

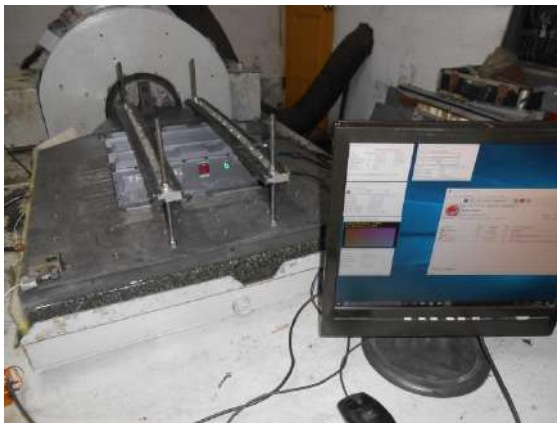
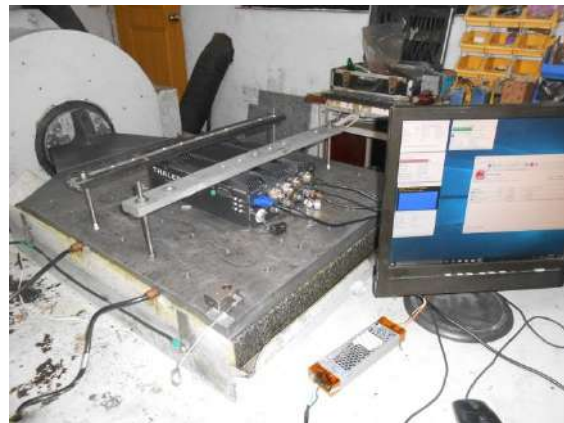
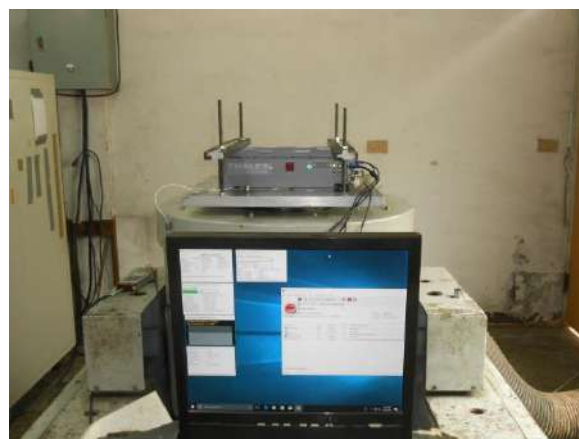
Fig. 7 : Random Vibration Test

Longitudinal Axis

Transverse Axis

Vertical Axis

1. Test configuration was shown in Fig.7.
2. The testing data were shown in Fig.8.
3. Test specimen was visually inspected after test. No physical damage occurred.
4. The function of specimen was normal during and after the Vibration test.

1. Test configurations were shown in Fig.7.
2. The testing data were shown in Fig.9.
3. Test specimen was visually inspected after test. No physical damage occurred.
4. The function of specimen was normal during and after Shock test.

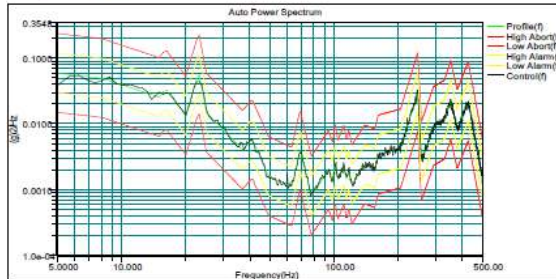
Longitudinal Axis

Test Name: 5-500Hz(X-2.05g).ucn
Test type: Random Test

Current Level: 100 % Demand RMS: 2.0973 g Control RMS: 2.10012 g
Frame Time: 1.600000 (s) Lines: 800 dF: 0.625000 Hz
DOF: 150 Test Elapsed: 00:40:19 Remaining Time: 00:00:00
Data was saved as a file at time: 2019-10-9 PM 06:07:23

G_{rms} level: Vertical 2.20 g_{rms}, Transverse 1.62 g_{rms}, Longitudinal 2.05 g_{rms}.

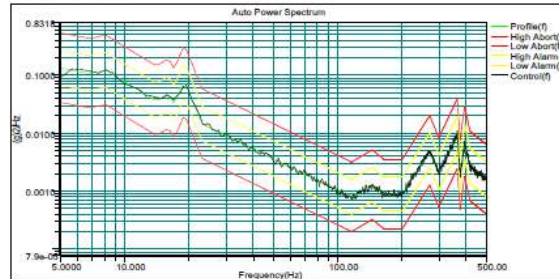
Transverse Axis

Test Name: 5-500Hz(Y-1.62g).ucn
Test type: Random Test

Current Level: 100 % Demand RMS: 1.59513 g Control RMS: 1.60527 g
Frame Time: 1.600000 (s) Lines: 800 dF: 0.625000 Hz
DOF: 150 Test Elapsed: 00:40:19 Remaining Time: 00:00:00
Data was saved as a file at time: 2019-10-16 PM 06:01:53

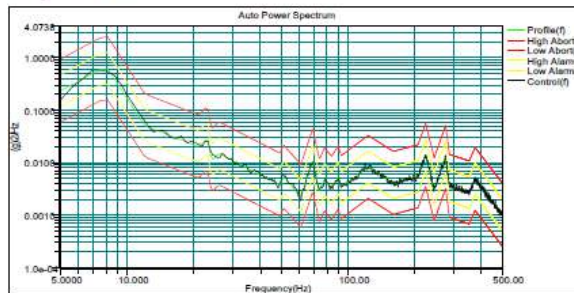
Vertical Axis

Test Name: 5-500Hz(Z-2.20g).ucn
Test type: Random Test

Current Level: 100 % Demand RMS: 2.18002 g Control RMS: 2.21484 g
Frame Time: 1.600000 (s) Lines: 800 dF: 0.625000 Hz
DOF: 150 Test Elapsed: 00:40:19 Remaining Time: 00:00:00
Data was saved as a file at time: 2019-10-9 PM 12:39:32

Fig. 8: Random Vibration Test Data
