Applicant : 7Starlake Co., Ltd.
2F., No.190, Sec. 2, Zhongxing Rd., Xindian Dist.,
New Taipei City 23146, Taiwan (R.O.C.)

Description : Sample Name Military Rugged GPU Server
Model Name AVR800-X1A
Date of Received AUG. 28, 2023
Date of Testing SEP. 03, 2023 ~ DEC. 25, 2023

1. High Temperature Storage Test

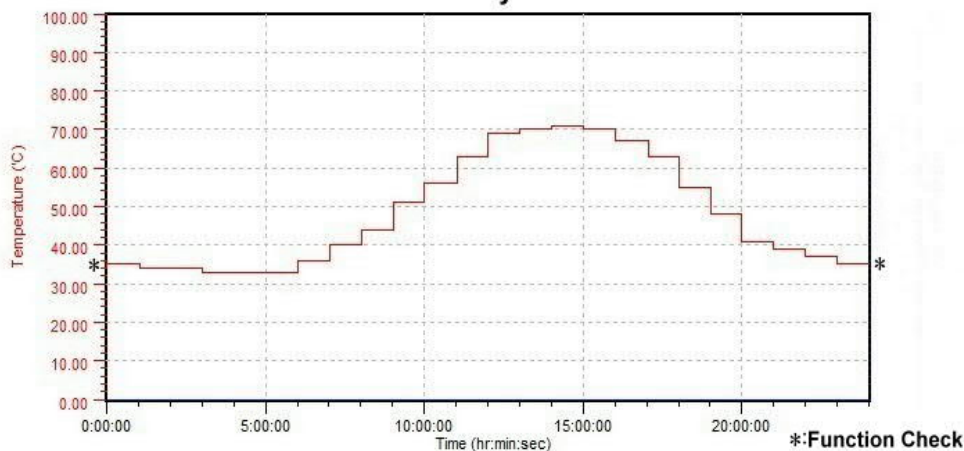
Step	Temperature (°C)	Time of day (h : min)	Number of Cycle	Condition
1	+35	01:00	7	Non-Operation Function check before and after the test.
2	+34	02:00		
3	+34	03:00		
4	+33	04:00		
5	+33	05:00		
6	+33	06:00		
7	+36	07:00		
8	+40	08:00		
9	+44	09:00		
10	+51	10:00

11	+56	11:00
12	+63	12:00
13	+69	13:00
14	+70	14:00
15	+71	15:00
16	+70	16:00
17	+67	17:00
18	+63	18:00
19	+55	19:00
20	+48	20:00
21	+41	21:00
22	+39	22:00
23	+37	23:00
24	+35	24:00

1 Cycle

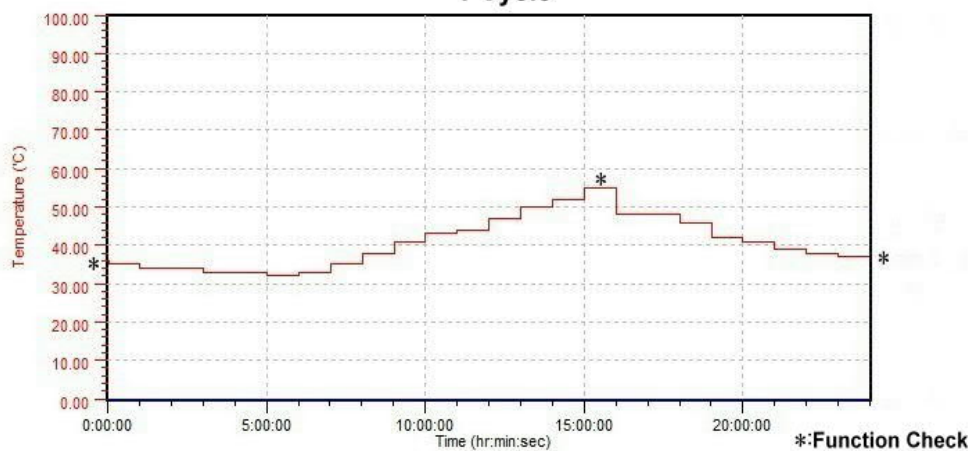
Step	Temperature (°C)	Time of day (h : min)	Number of Cycle	Condition
1	+35	01:00	3	Operation Function check before, after the test and at the maximum temp. of each one of 3 cycles.
2	+34	02:00		
3	+34	03:00		
4	+33	04:00		
5	+33	05:00		
6	+32	06:00		
7	+33	07:00		
8	+35	08:00		
9	+38	09:00		
10	+41	10:00

11	+43	11:00
12	+44	12:00
13	+47	13:00
14	+50	14:00
15	+52	15:00
16	+55	16:00
17	+48	17:00
18	+48	18:00
19	+46	19:00
20	+42	20:00
21	+41	21:00
22	+39	22:00
23	+38	23:00
24	+37	24:00

1 Cycle

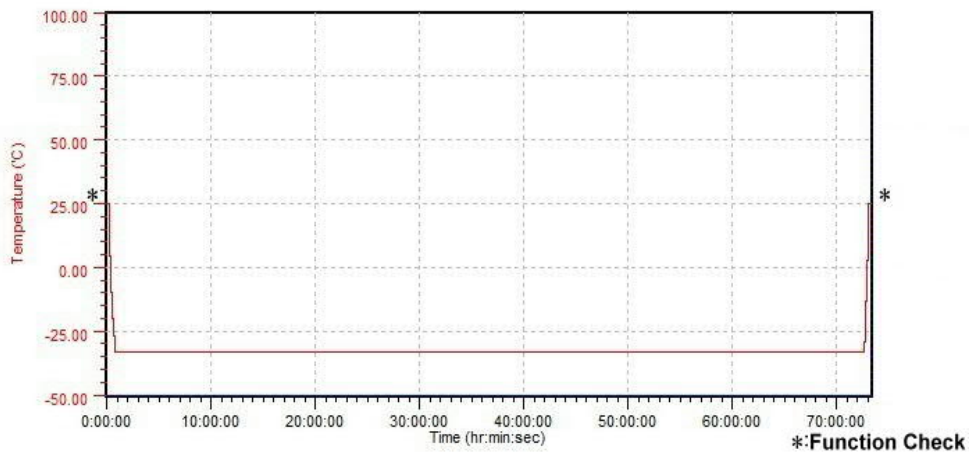
Step	Temperature (°C)	Duration (h : min)	Number of Cycles	Temp. Ramp (°C/min)	Condition
1	+25	00:05	1	2	Function Check
2	-33	72:00			Non-Operation
4	+25	00:05			Function Check

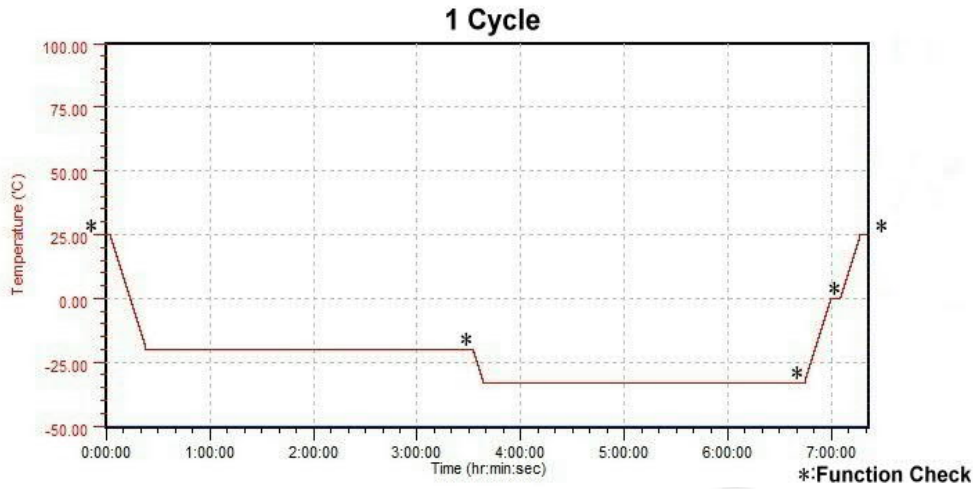
Step	Temperature (°C)	Duration (h : min)	Number of Cycles	Temp. Ramp (°C/min)	Condition
1	+25	00:05	3	2	Function check before, after the test and at last 5 minutes of -20°C, -33°C and 0°C period.
2	-20	03:00			
4	-33	03:00			
5	0	00:05			
6	+25	00:05

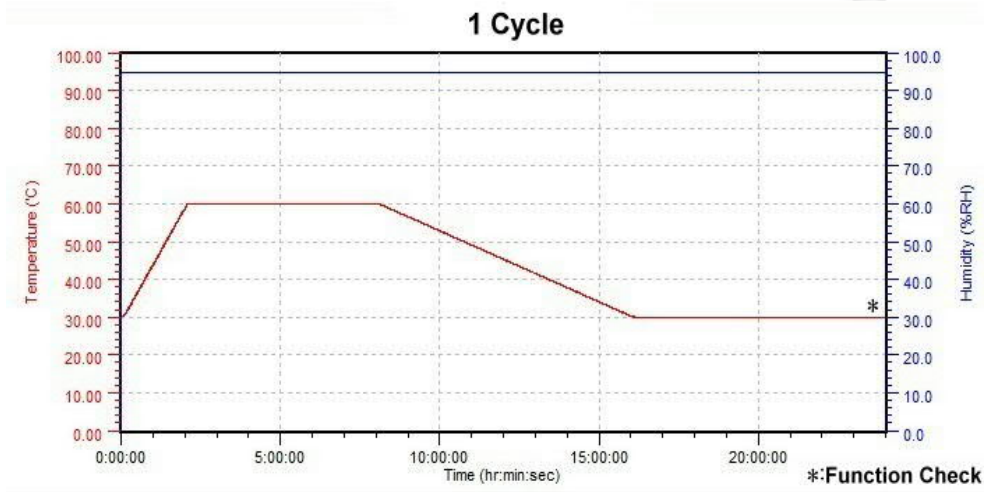
Step	Temperature (°C)	Humidity (%RH)	Duration (h : min)	Number of Cycles	Condition
1	+30	95	00:10	1	Function check before, after the test and prior to end of the 5 th and 10 th cycle.
2	+30 to +60	95	02:00	10	
3	+60	95	06:00		
4	+60 to +30	95	08:00		
5	+30	95	08:00
