VIBRATION SOURCE TECHNOLOGY CO., LTD.

Report No.: VS-TV-1140102-07

Test Report

Specimen :	SN2010-AA-HSC
Applicant Name :	PERFECTRON CO., LTD. TAIWAN BRANCH (B.V.I)
Applicant Address :	2 F., No. 190, Sec. 2, Zhongxing Rd., Xindian Dist., New Taipei City 23146, Taiwan (R.O.C.)

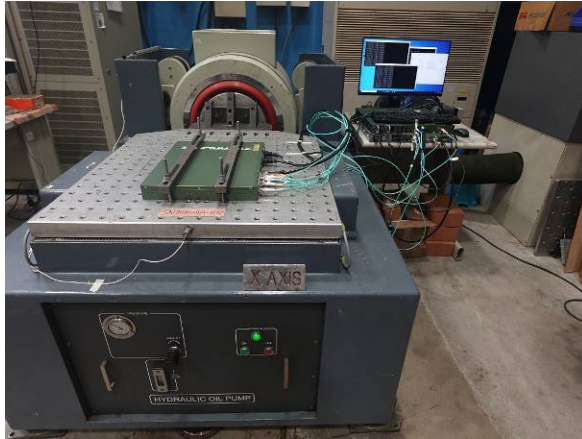
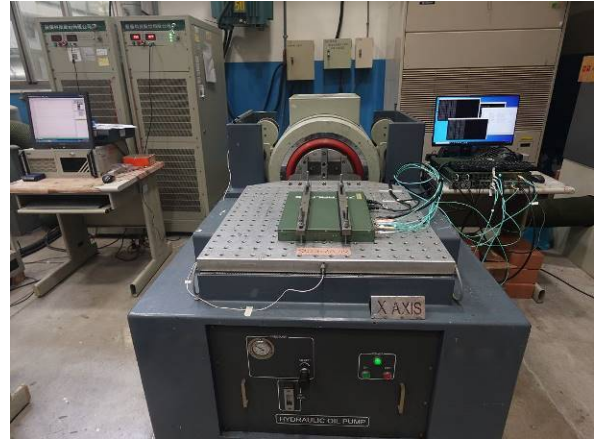
FIG.1.1 : X Axis direction mounted.

FIG.1.2 : X Axis direction mounted.

Test Report No.	VS-TD-1140102-07
Applicant Name	PERFECTRON CO., LTD. TAIWAN BRANCH (B.V.I)
Specimen	SN2010-AA-HSC
Quantity	1 PCS
Date of Test	Dec 25, 2024
Test Item	Test 1: Vibration Test
Sample Condition	Operating
Test Condition	<p>Waveform: Random Wave</p> <p>Frequency Range: (500 ~ 2000) Hz</p> <p>Acceleration: 5 Grms</p> <p>PSD: 0.0167 G² / Hz</p> <p>Vibration Axial: (X · Y · Z) Axis</p> <p>Single Axis Time: 30 minutes</p> <p>Total Time: 90 minutes</p> <p>FIG 1.1 ~ 1.2: X axis direction mounted</p> <p>FIG 2: X axis test screen</p> <p>FIG 3.1 ~ 3.2: Y axis direction mounted</p> <p>FIG 4: Y axis test screen</p> <p>FIG 5.1 ~ 5.2: Z axis direction mounted</p> <p>FIG 6: Z axis test screen</p>

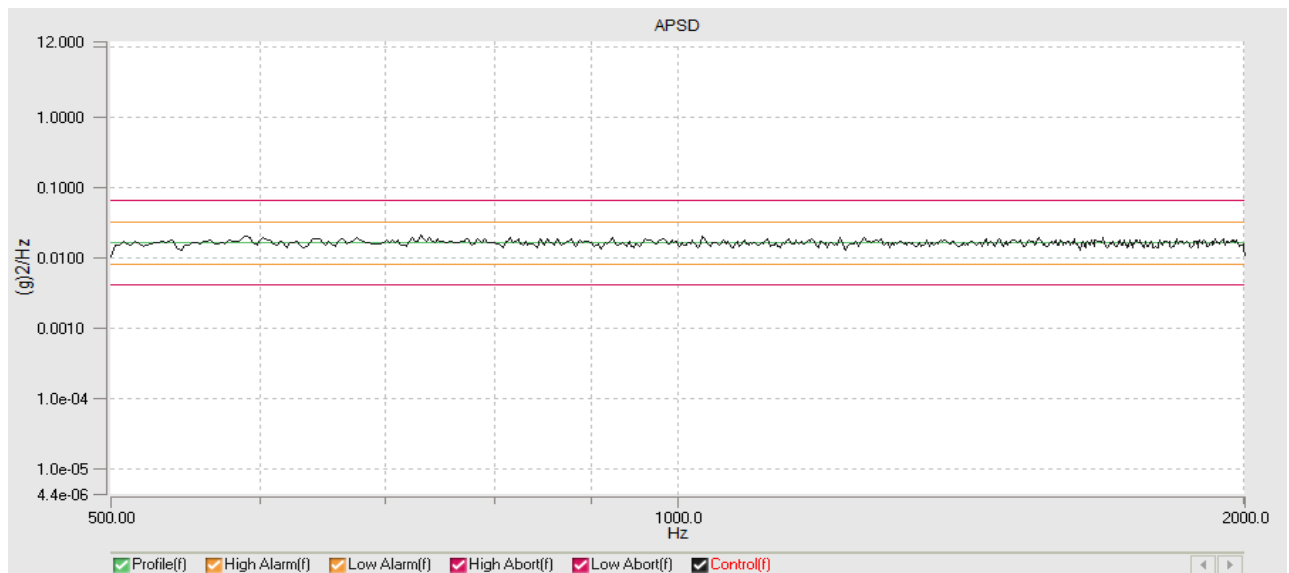
FIG.2 : X Axis Test screen.

Demand RMS: 5.002 g

Control RMS: 5.002 g

Frame Time: 0.4000 (s)

Lines: 800

dF: 2.5 Hz

DOF: 300

Current Level Time: 00:30:00

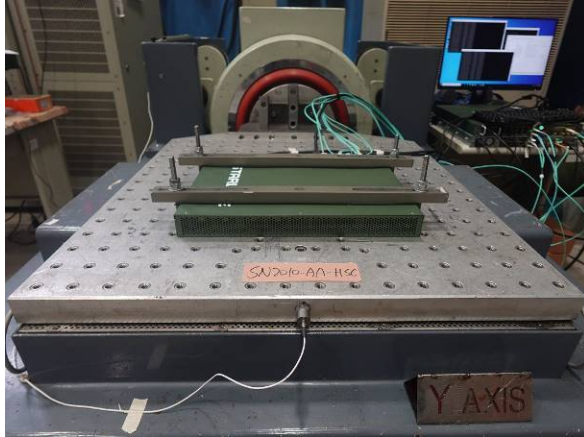
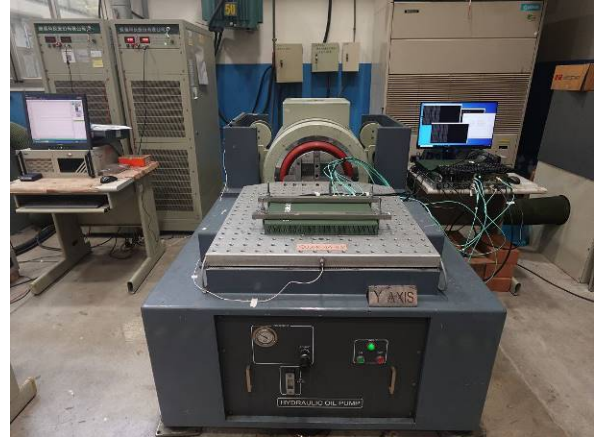
FIG.3.1 : Y Axis direction mounted.

FIG.3.2 : Y Axis direction mounted.

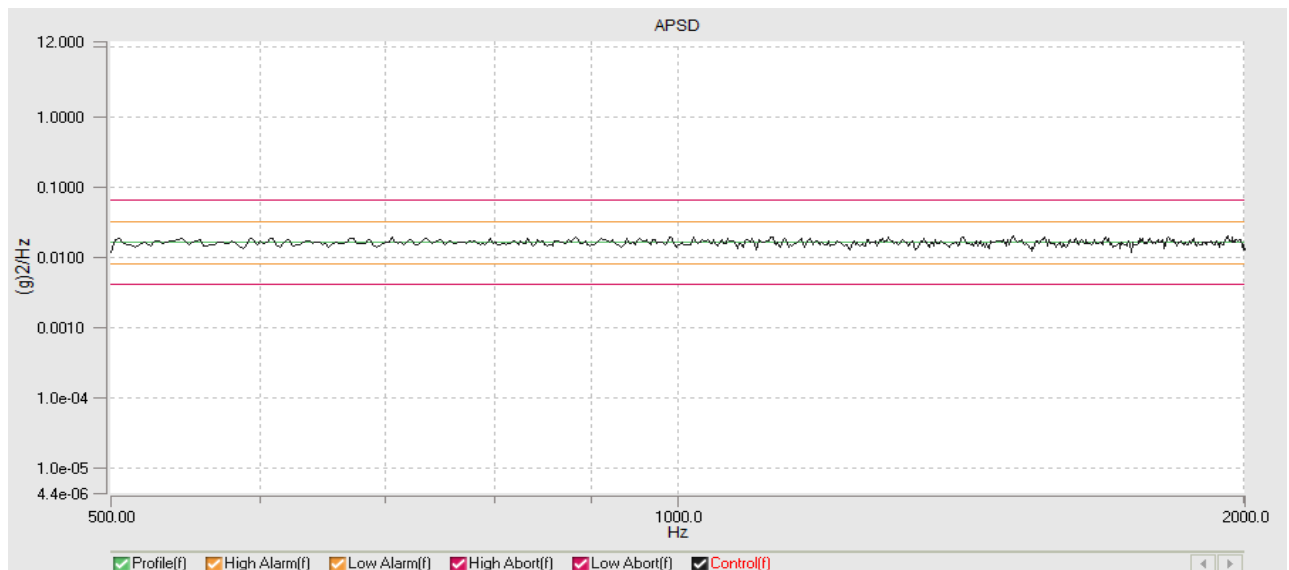
FIG.4 : Y Axis Test screen.

Demand RMS: 5.002 g

Control RMS: 4.990 g

Frame Time: 0.4000 (s)

Lines: 800

dF: 2.5 Hz

DOF: 300

Current Level Time: 00:30:00

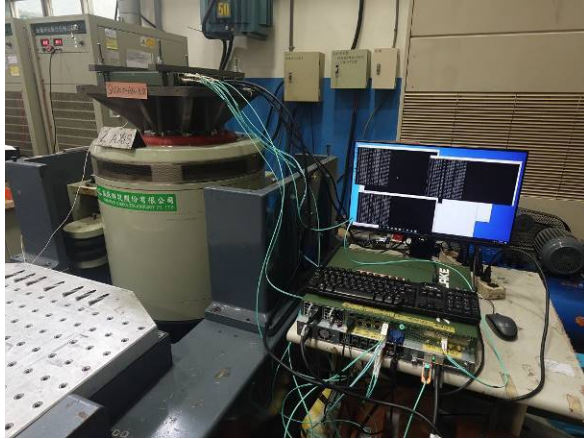
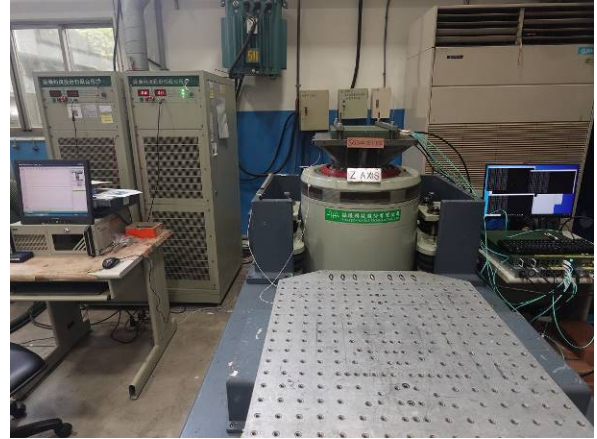
FIG.5.1 : Z Axis direction mounted.

FIG.5.2 : Z Axis direction mounted.

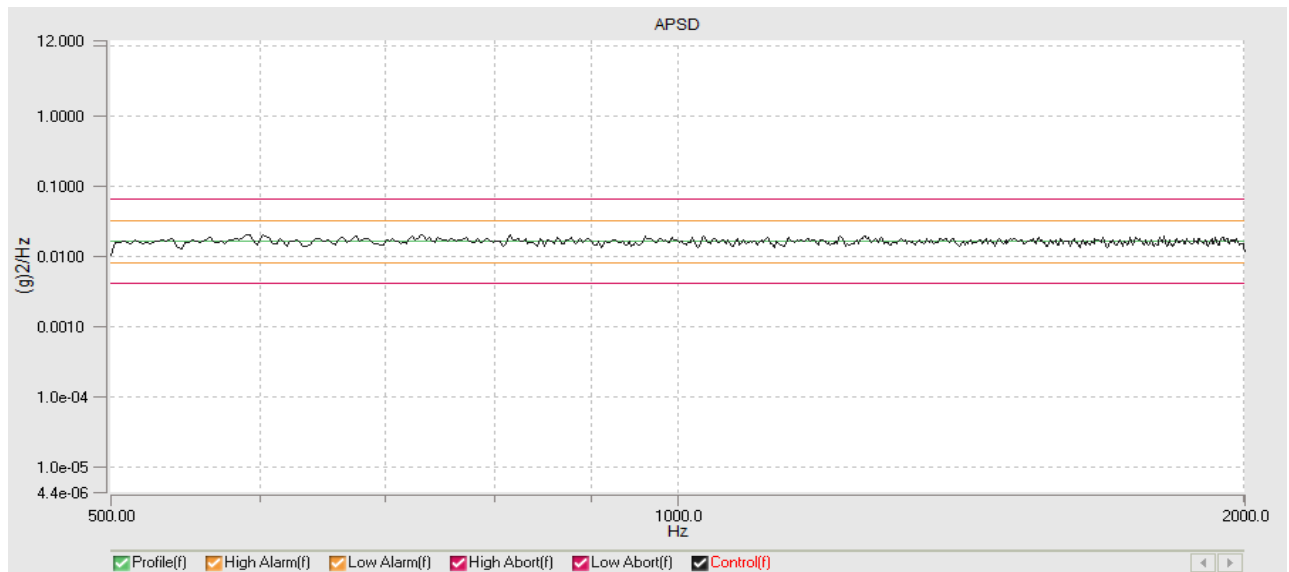
FIG.6 : Z Axis Test screen.

Demand RMS: 5.002 g

Control RMS: 4.998 g

Frame Time: 0.4000 (s)

Lines: 800

dF: 2.5 Hz

DOF: 300

Current Level Time: 00:30:00

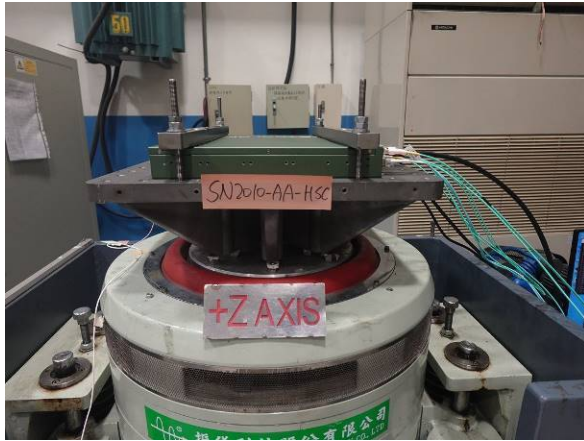
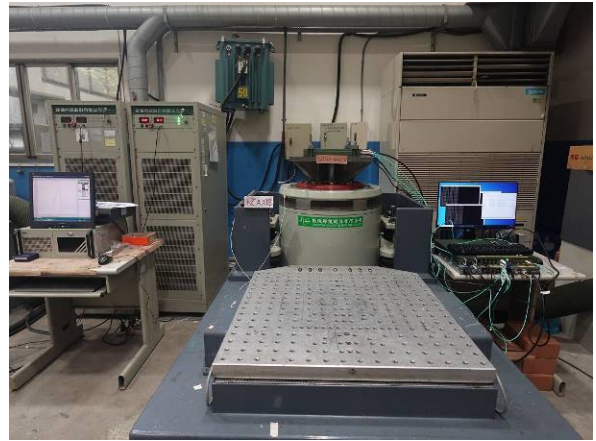
FIG.7.1 : +Z Axis direction mounted.

FIG.7.2 : +Z Axis direction mounted.

Test Item	Test 2 : Shock Test	
Sample Condition	Operating	
Test Condition	Waveform:	Half Sine Wave
	Shock	
	Peak Acceleration:	40 G
	Duration Time :	11 ms
	Vibration Axial:	+Z 、 -Z Axis
	Shock Time:	1 time
	Total Time:	2 times
	FIG 7.1 ~ 7.2:	+Z axis direction mounted
	FIG 8:	+Z axis test screen
	FIG 9.1 ~ 9.2:	-Z axis direction mounted
	FIG 10:	-Z axis test screen
Test Result	Appearance: No external physical damage.	
	Function: Upon Applicant's comment.	
Test Conducted By		Report Prepared By
Manson		Jane
<i>Manson</i>		<i>Jane</i>

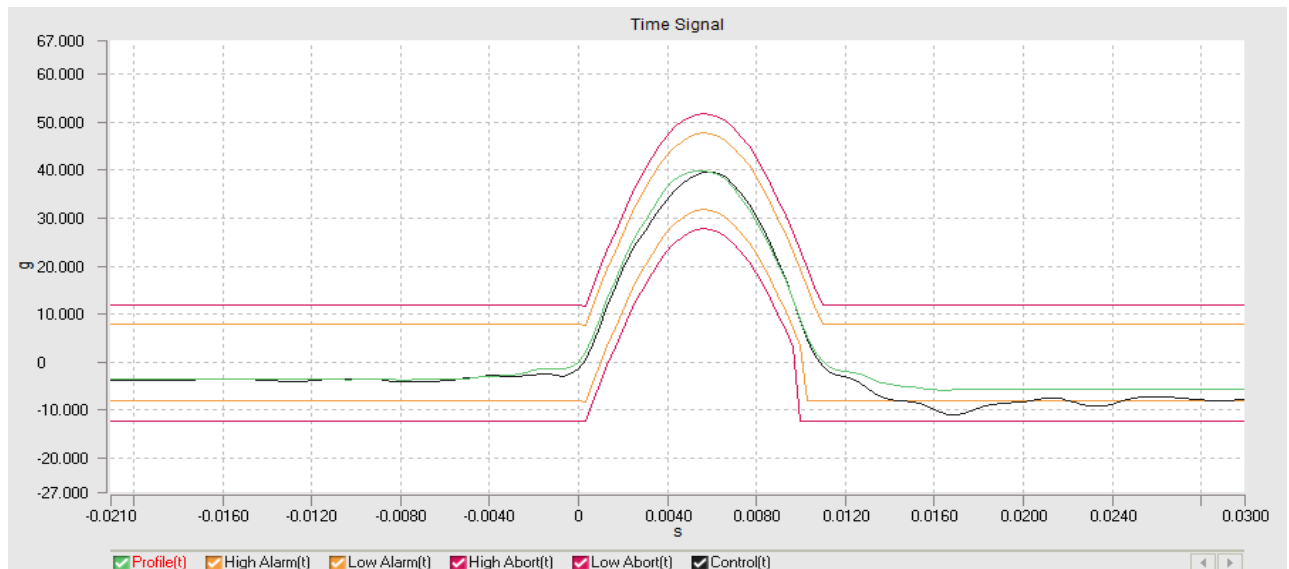
FIG.8 : +Z Axis Test screen.

Shock Type:Half Sine

Mag:40.00 g

Demand peak: 40.000 g

Frame Time:0.6827 s

Pulse Duration:11 ms

Control peak:39.689 g

dT:0.000333333 s

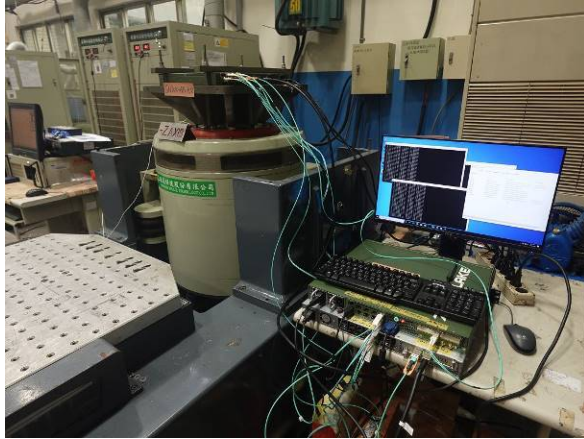
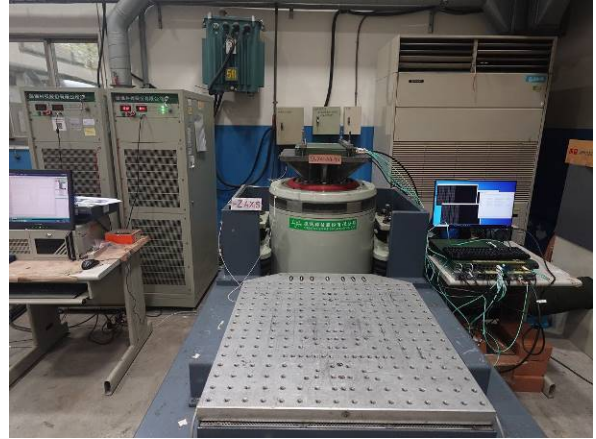
FIG.9.1 : -Z Axis direction mounted.

FIG.9.2 : -Z Axis direction mounted.

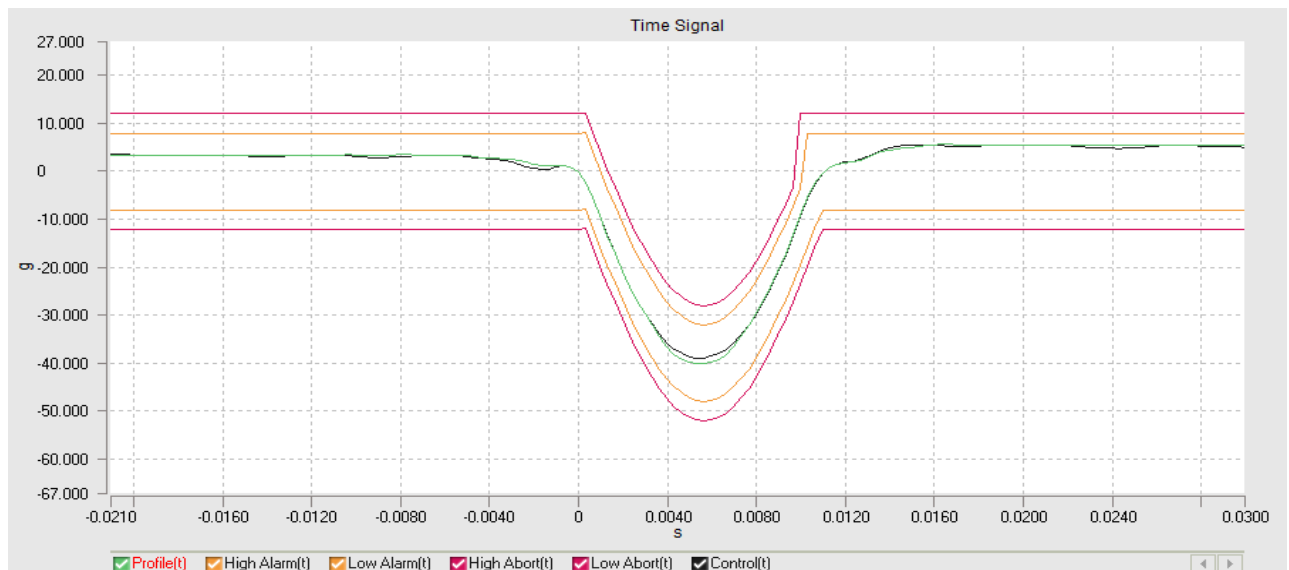
FIG.10 : -Z Axis Test screen.

Shock Type:Half Sine

Mag:40.00 g

Demand peak: 40.000 g

Frame Time:0.6827 s

Pulse Duration:11 ms

Control peak:38.741 g

dT:0.000333333 s
