Report No.: VS-TV-1140122-01

Test Report

Specimen:	HORUS440
Applicant Name :	7StarLake
Applicant Address :	2 F., No. 190, Sec. 2, Zhongxing Rd., Xindian Dist., New Taipei City 23146, Taiwan (R.O.C.)

Test 1: Vibration Test (Operating)

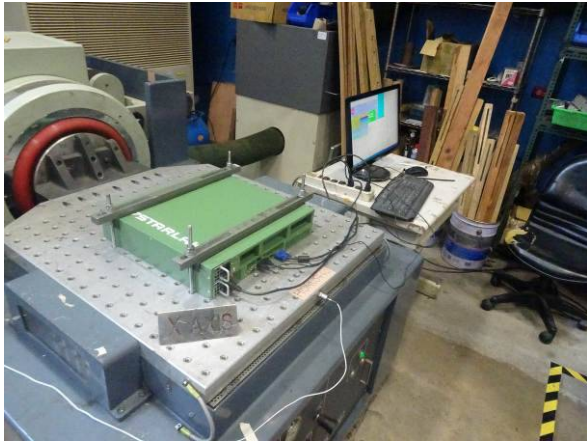
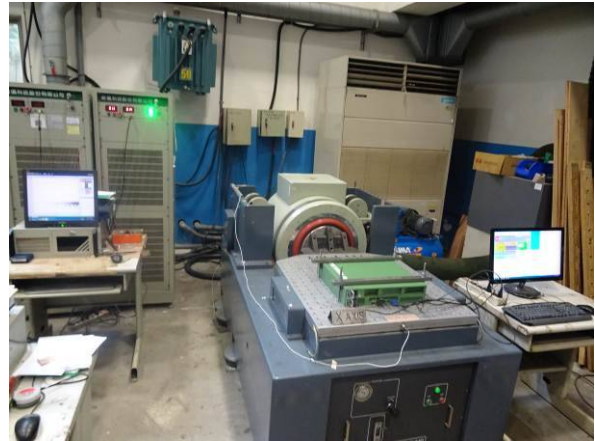
FIG.1.1 : X Axis direction mounted.

FIG.1.2 : X Axis direction mounted.

Test Item	Test 1 : Vibration Test
Sample Condition	Operating
Test Condition	Waveform: Random Wave Frequency Range: (5 ~ 2000) Hz Acceleration: 5 Grms PSD: 0.01257 g ² /Hz Vibration Axial: X, Y, Z Single Axis Time: 30 minutes Total Time: 90 minutes FIG 1.1 ~ 1.2: X axis direction mounted FIG 2: X axis test screen FIG 3.1 ~ 3.2: Y axis direction mounted FIG 4: Y axis test screen FIG 5.1 ~ 5.2: Z axis direction mounted FIG 6: Z axis test screen
Test Result	Appearance: No external physical damage , PASS. Function: PASS.

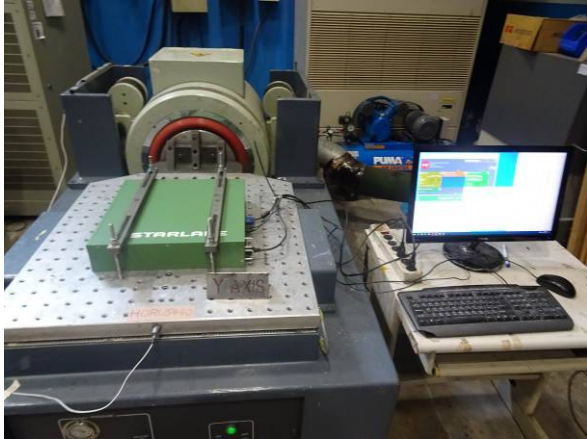
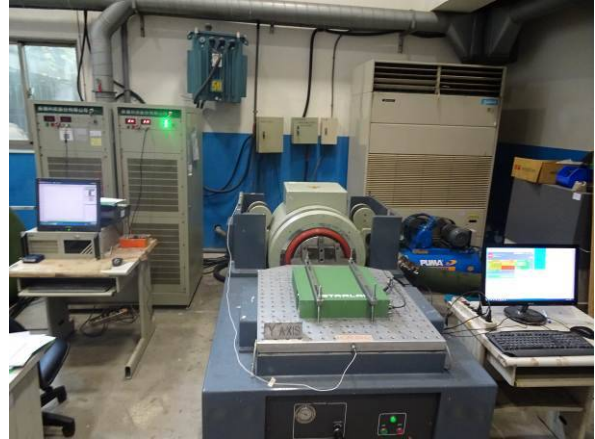
FIG.3.1 : Y Axis direction mounted.

FIG.3.2 : Y Axis direction mounted.

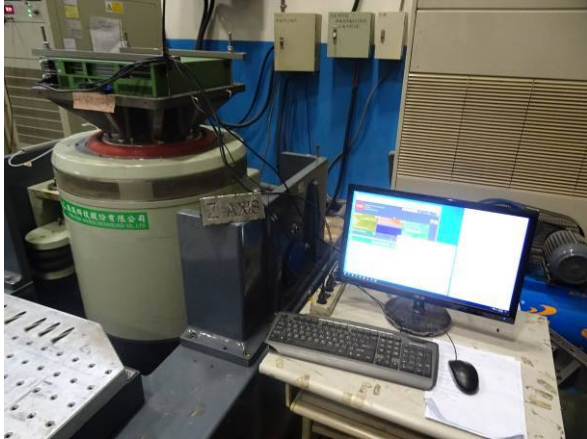
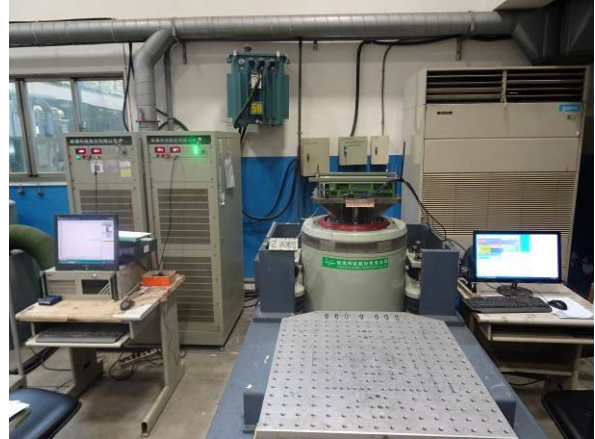
FIG.5.1 : Z Axis direction mounted.

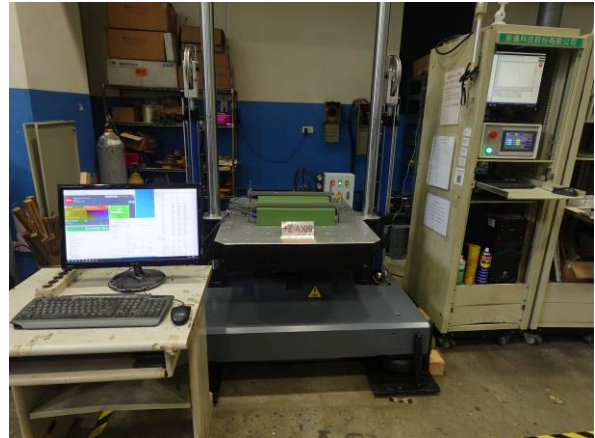
FIG 7.1: +Z axis direction mounted

FIG 7.2: +Z axis direction mounted

Test Item	Test 2: Shock Test	
Sample Condition	Operating	
Test Condition	Waveform:	Half Sine Wave
	Shock Peak Acceleration:	20 G
	Duration Time:	11 ms
	Vibration Axial:	± Z Axis
	Shock Time:	1 time
	Total Time:	2 times
	FIG 7.1 ~ 7.2:	+Z axis direction mounted
	FIG 8:	+Z axis test screen
	FIG 9.1 ~ 9.2:	-Z axis direction mounted
	FIG 10:	-Z axis test screen
Test Result	Appearance: No external physical damage , PASS.	
	Function: PASS.	
Test Conducted By		Report Prepared By
Zhou Jia-chuan		Chen Qiong-zhen
<i>Zhou Jia-chuan</i>		<i>Chen Qiong zhen</i>

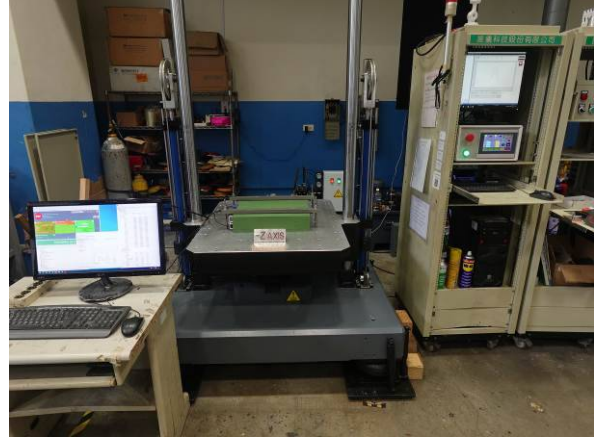
FIG 9.1: -Z axis direction mounted

FIG 9.2: -Z axis direction mounted
