**Report No.: VS-TV-1140211-03**

# Test Report

**Specimen: 7SL-XR5610**  
**Applicant Name : 7StarLake**  
**Applicant Address : 2 F., No. 190, Sec. 2, Zhongxing Rd., Xindian Dist.,  
New Taipei City 23146, Taiwan (R.O.C.)**

### Test 1: Vibration Test (Operating)

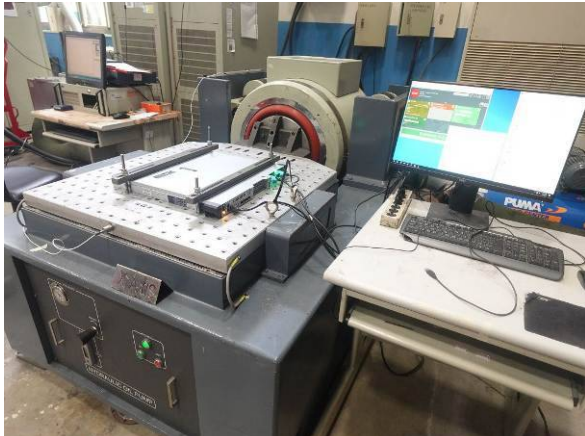
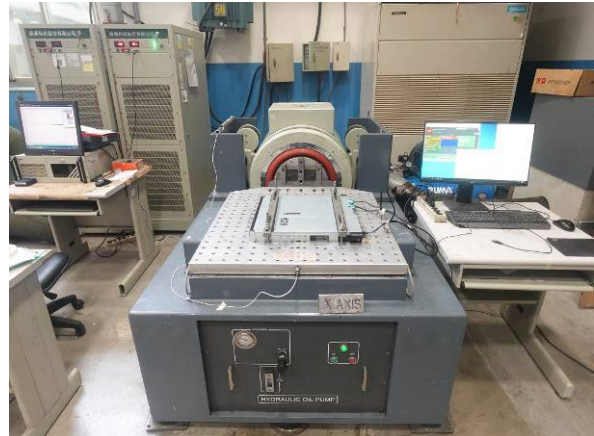
FIG.1.1 : X Axis direction mounted.

FIG.1.2 : X Axis direction mounted.

Test Item	Test 1 : Vibration Test
Sample Condition	Operating
Test Condition	Waveform: Random Wave Frequency Range: (5 ~ 2000) Hz Acceleration: 5 Grms PSD: 0.01257 g <sup>2</sup> /Hz Vibration Axial: X, Y, Z Single Axis Time: 30 minutes Total Time: 90 minutes FIG 1.1 ~ 1.2: X axis direction mounted FIG 2: X axis test screen FIG 3.1 ~ 3.2: Y axis direction mounted FIG 4: Y axis test screen FIG 5.1 ~ 5.2: Z axis direction mounted FIG 6: Z axis test screen
Test Result	Appearance: No external physical damage , PASS. Function: PASS.

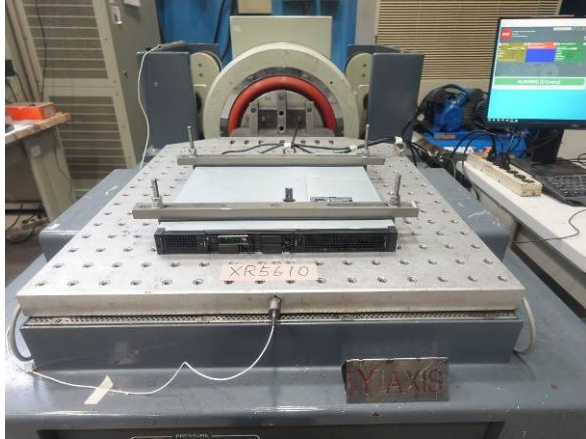
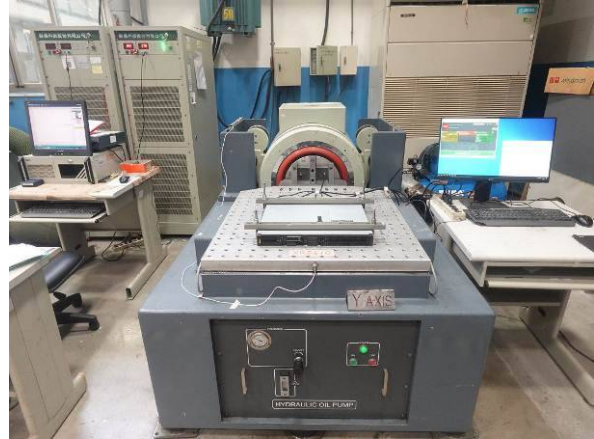
FIG.3.1 : Y Axis direction mounted.

FIG.3.2 : Y Axis direction mounted.

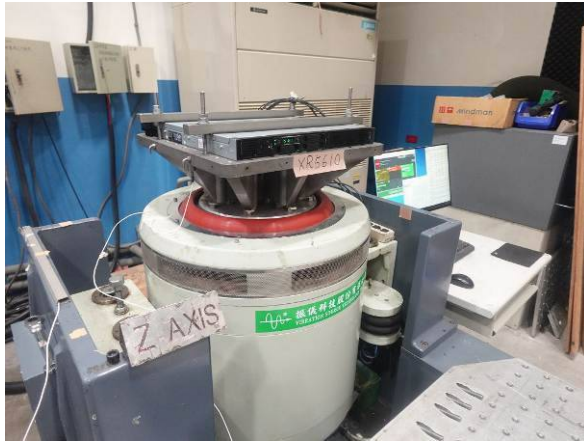
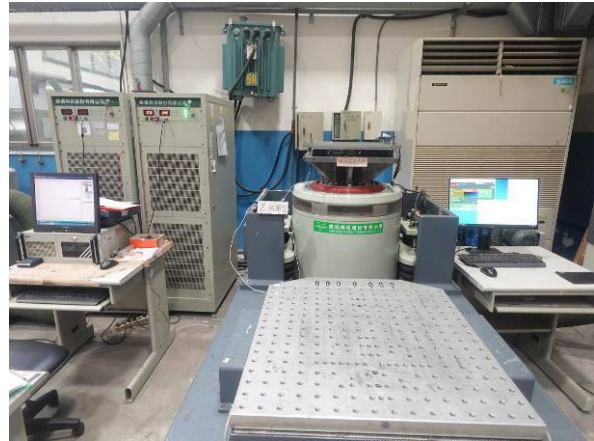
FIG.5.1 : Z Axis direction mounted.

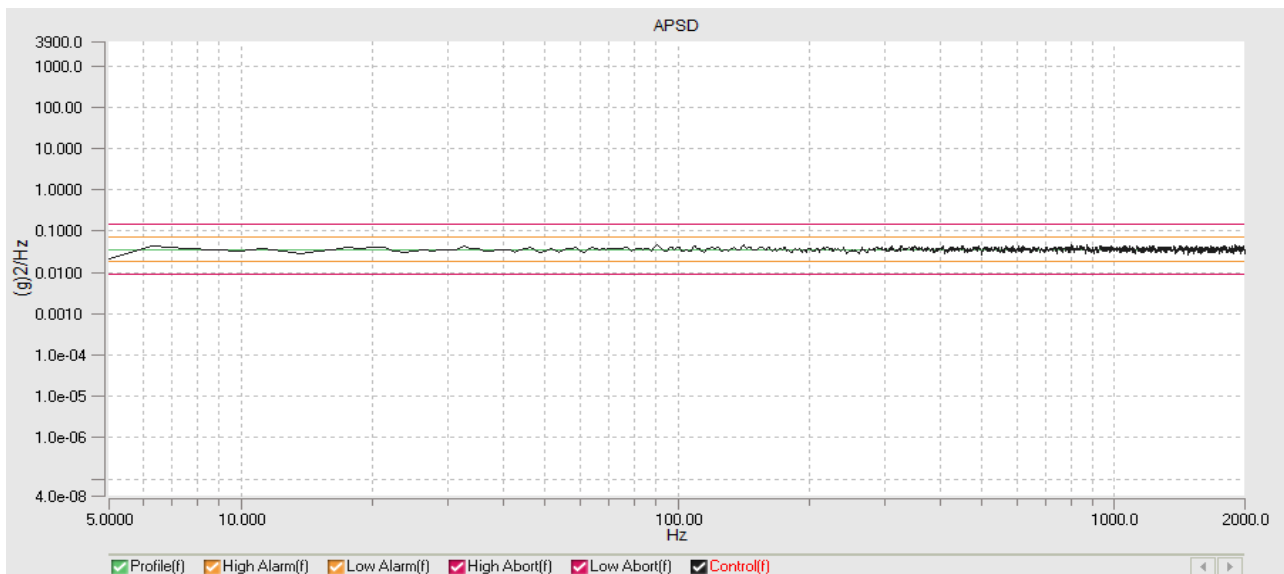
FIG.6 : Z Axis Test screen.

Demand RMS: 8.656 g

Control RMS: 8.663 g

dF: 1.3 Hz

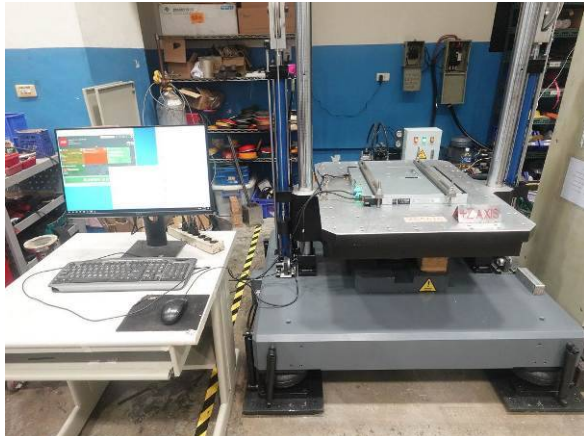
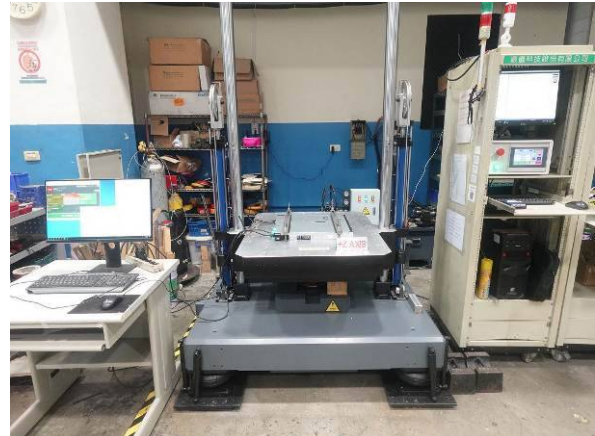
FIG 7.1: +Z axis direction mounted

FIG 7.2: +Z axis direction mounted

<b>Test Item</b>	<b>Test 2: Shock Test</b>	
<b>Sample Condition</b>	<b>Operating</b>	
Test Condition	Waveform:	Half Sine Wave
	Shock Peak Acceleration:	20 G
	Duration Time:	11 ms
	Vibration Axial:	± Z Axis
	Shock Time:	1 time
	Total Time:	2 times
	FIG 7.1 ~ 7.2:	+Z axis direction mounted
	FIG 8:	+Z axis test screen
	FIG 9.1 ~ 9.2:	-Z axis direction mounted
	FIG 10:	-Z axis test screen
Test Result	Appearance: No external physical damage · PASS.	
	Function: PASS.	
Test Conducted By		Report Prepared By
Zhou Jia-chuan		Chen Qiong-zhen
<i>Zhou Jia-chuan</i>		<i>Chen Qiong zhen</i>

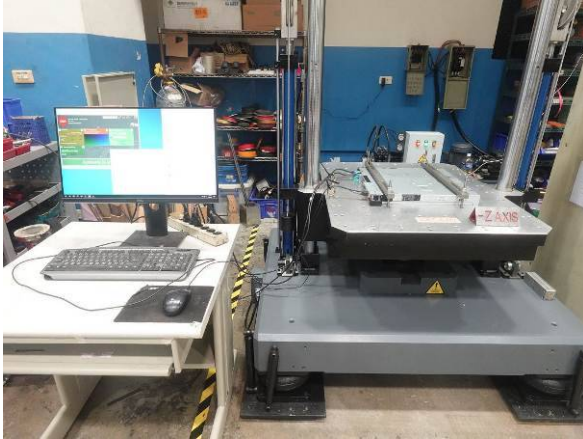
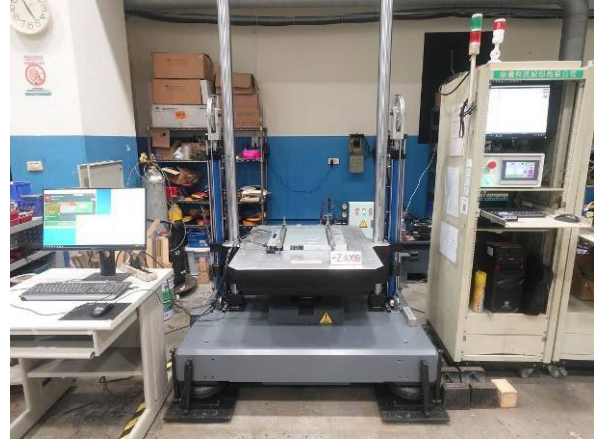
FIG 9.1: -Z axis direction mounted

FIG 9.2: -Z axis direction mounted
