Test Report

Specimen: 7SL-XR5610
Applicant Name : 7StarLake
**Applicant Address : 2 F., No. 190, Sec. 2, Zhongxing Rd., Xindian Dist.,
New Taipei City 23146, Taiwan (R.O.C.)**

Test 1: Vibration Test (Non-Operating)

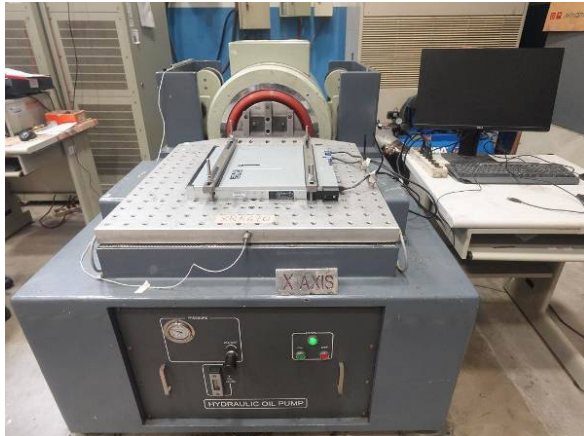
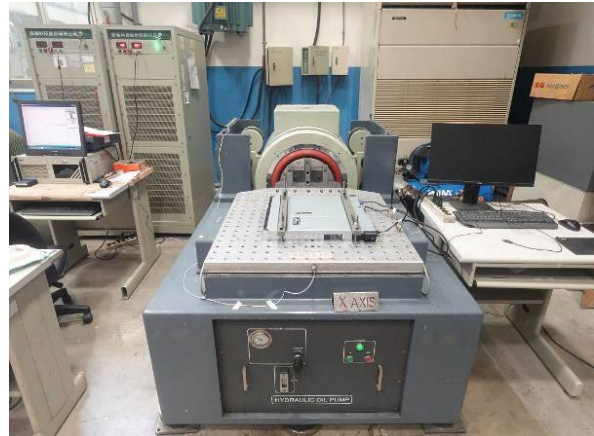
FIG.1.1 : X Axis direction mounted.

FIG.1.2 : X Axis direction mounted.

Test Item	Test 1 : Vibration Test
Sample Condition	Non-Operating
Test Condition	Waveform: Random Wave Frequency Range: (5 ~ 2000) Hz Acceleration: 7.5 Grms PSD: 0.028238 g ² /Hz Vibration Axial: X, Y, Z Single Axis Time: 30 minutes Total Time: 90 minutes FIG 1.1 ~ 1.2: X axis direction mounted FIG 2: X axis test screen FIG 3.1 ~ 3.2: Y axis direction mounted FIG 4: Y axis test screen FIG 5.1 ~ 5.2: Z axis direction mounted FIG 6: Z axis test screen
Test Result	Appearance: No external physical damage , PASS. Function: Upon Applicant's comment , PASS.

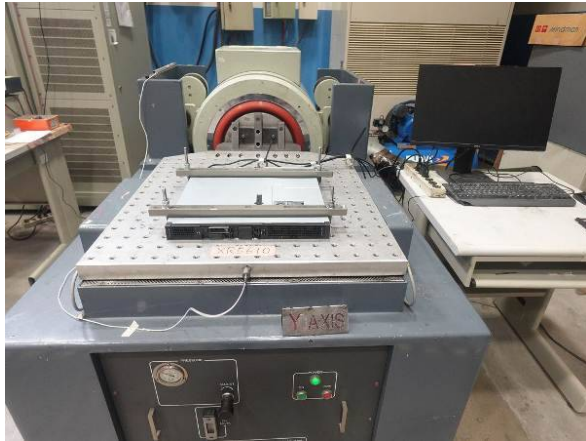
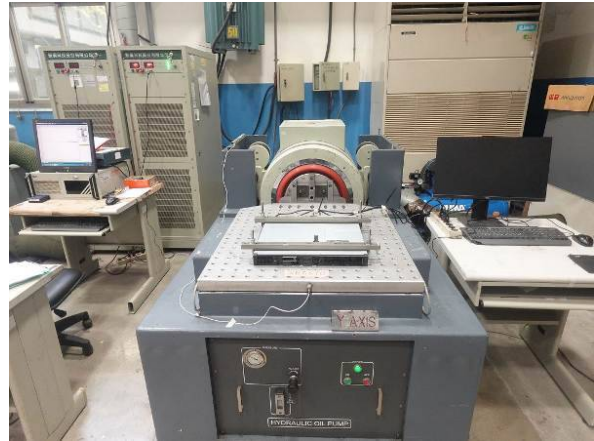
FIG.3.1 : Y Axis direction mounted.

FIG.3.2 : Y Axis direction mounted.

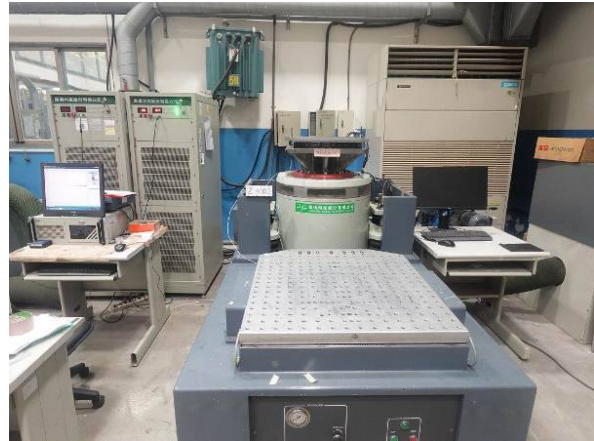
FIG.5.1 : Z Axis direction mounted.

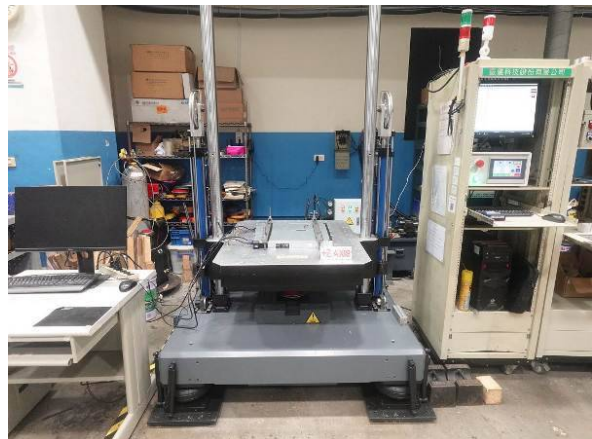
FIG 7.1: +Z axis direction mounted

FIG 7.2: +Z axis direction mounted

Test Item	Test 2: Shock Test	
Sample Condition	Operating	
Test Condition	Waveform:	Half Sine Wave
	Shock Peak Acceleration:	40 G
	Duration Time:	11 ms
	Vibration Axial:	± Z Axis
	Shock Time:	1 time
	Total Time:	2 times
	FIG 7.1 ~ 7.2:	+Z axis direction mounted
	FIG 8:	+Z axis test screen
	FIG 9.1 ~ 9.2:	-Z axis direction mounted
	FIG 10:	-Z axis test screen
Test Result	Appearance: No external physical damage , PASS.	
	Function: Upon Applicant's comment , PASS.	
Test Result	Appearance: No external physical damage , PASS.	
	Function: Upon Applicant's comment , PASS.	
Test Conducted By		Report Prepared By
Zhou Jia-chuan		Chen Qiong-zhen
<i>Zhou Jia-chuan</i>		<i>Chen Qiong zhen</i>

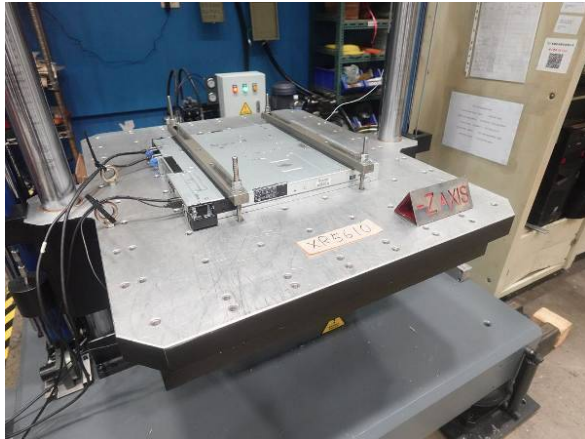
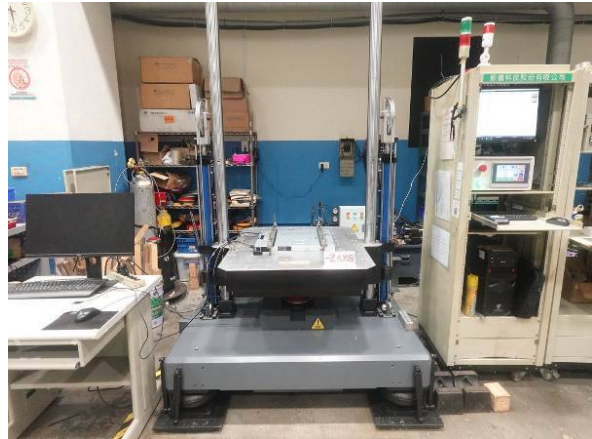
FIG 9.1: -Z axis direction mounted

FIG 9.2: -Z axis direction mounted

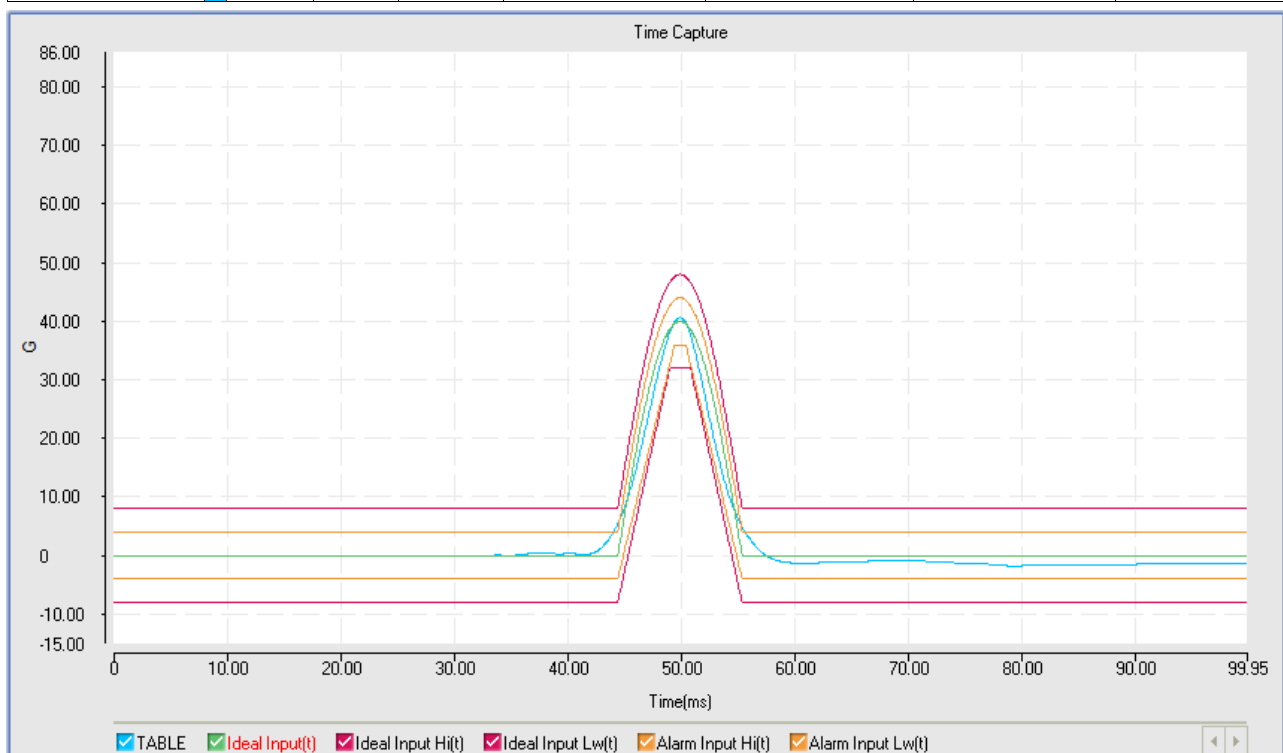
FIG 10 : -Z Axis Test screen.

Name	G	ms	cm/s	LP Filter(Hz)	Maximum(G)	Minimum(G)	Description
Ideal Input(t)	40.00	11.00	274.16	--	40.00	0.00	
TABLE	40.61	11.59	261.62	363.64	40.61	-1.75

Total Frames:23 Current Frames:23
